CULVERT INSPECTION REPORT

2020 Bridge & Culvert Inspections

Townline Culvert
23

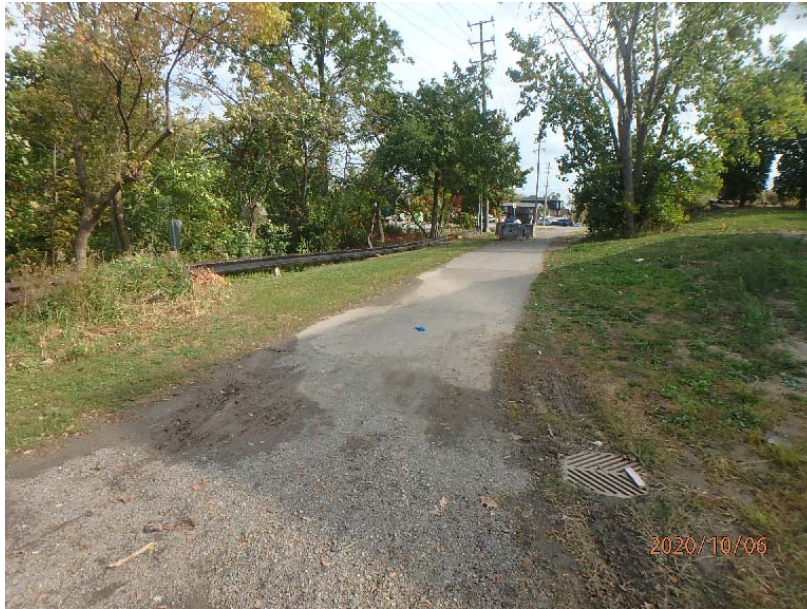
Photograph No. 1: 0013: Roadway over the structure looking east.

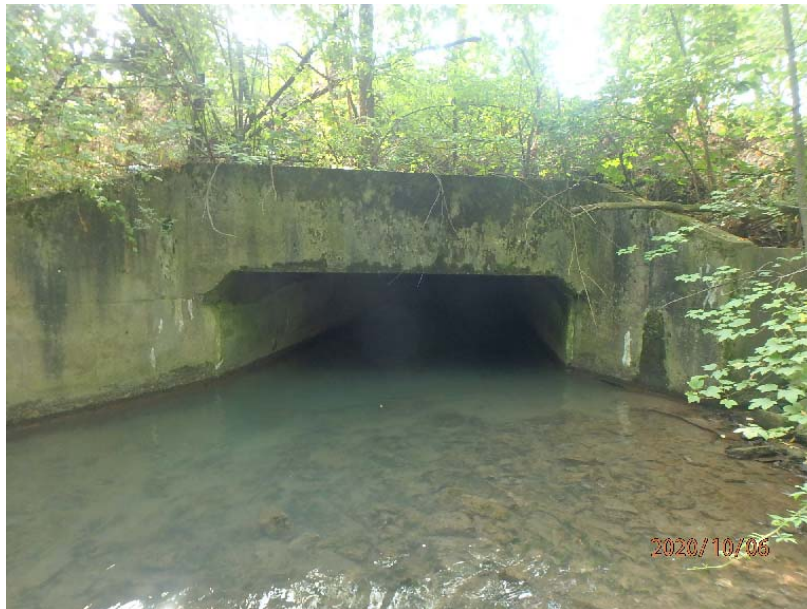
Photograph No. 2: 0033: North elevation.

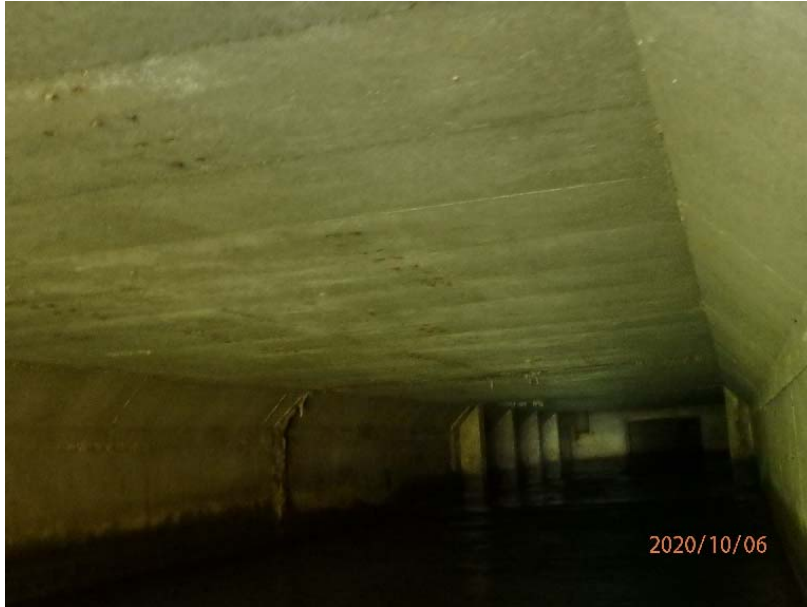
Photograph No. 3: 0065: Interior of structure looking south.

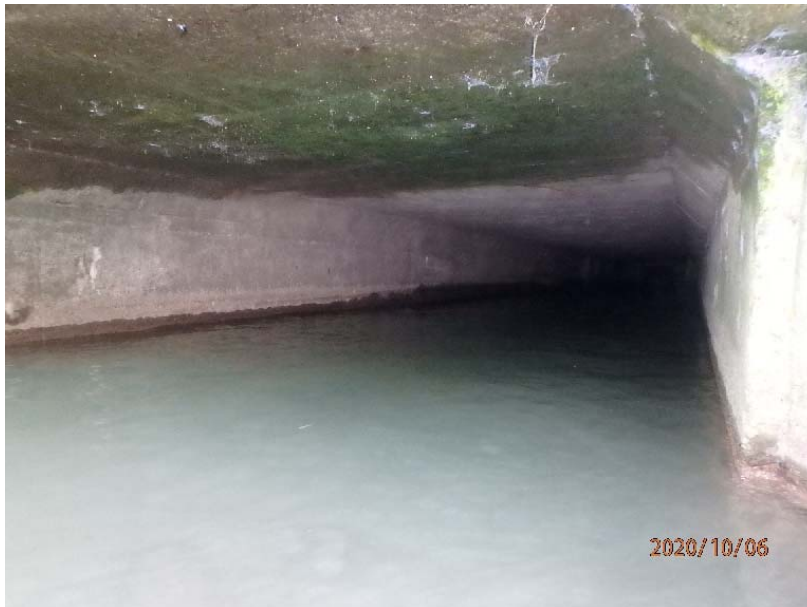
Photograph No. 4: 0037: Interior of structure looking south.
