# **Terra-Dynamics Consulting Inc.**

Re: Hydrogeologic Study and Wetland Water Balance, 436 Quaker Road, Welland,  
and Lot 228/Part Lot 174, Thorold, ON

Terra-Dynamics Consulting Inc. respectfully submits this DRAFT Hydrogeologic Study and Wetland Water Balance of 436 Quaker Road Welland, and Lot 228/Part Lot 174, Thorold (the Site, Figure 1, see attachments). The rectangular 60.8 hectare Site is located at the northwest corner of Quaker Road and First Avenue, within both the City of Welland (southern part of Site) and south of an unopened Merritt Road allowance within the City of Thorold (northern part of Site) (Figures 1 and 2, see attachments). This report has been completed as part of planning for future residential development of the currently agricultural lands. No tile-drainage is mapped for the Site (OMAFRA, 2023).

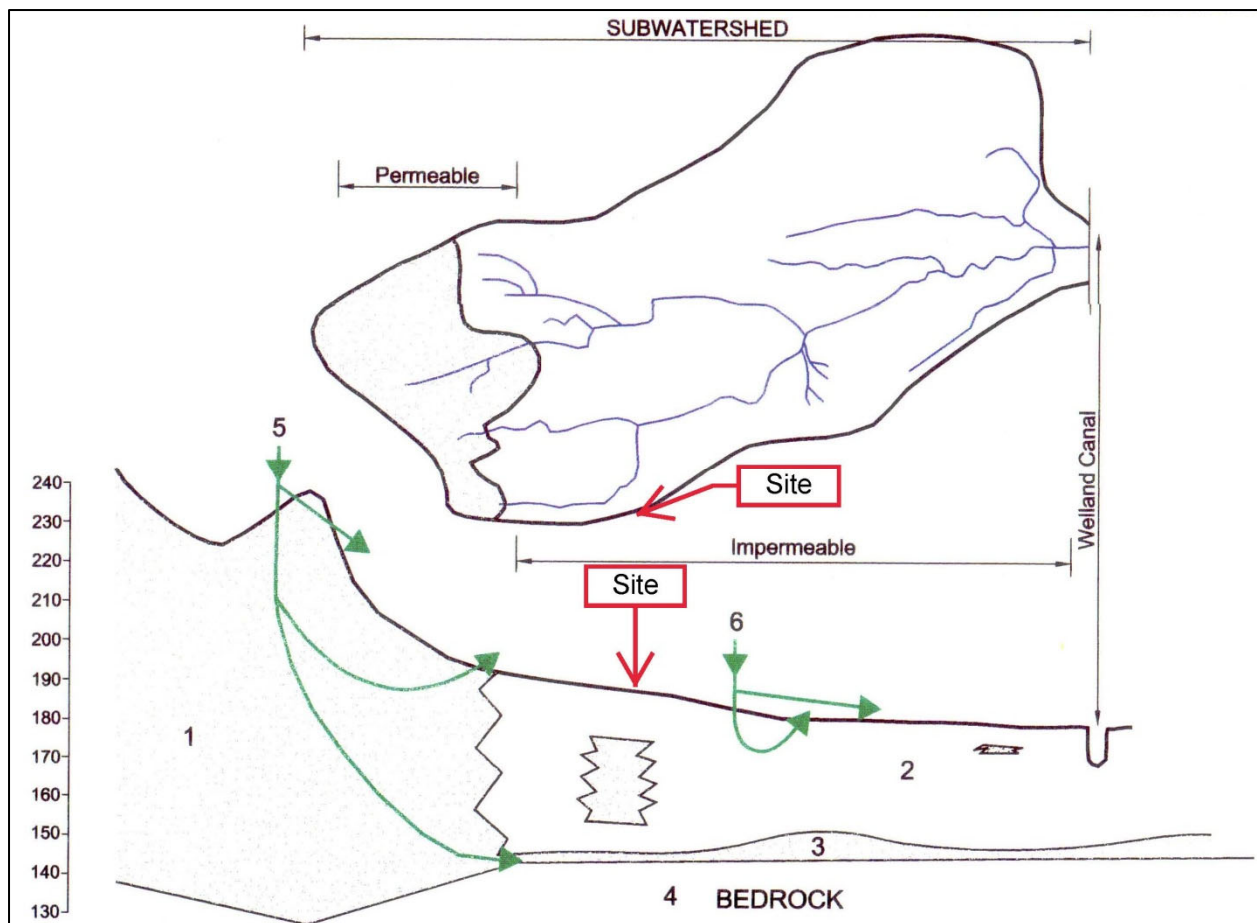
4. The subwatershed is underlain by dolostone bedrock;
5. Precipitation falling within the western half of the subwatershed, could (a) runoff, (b) recharge radially from the topographic height, to the deeper aquifer units, such as bedrock, or the lower sand, or (c) discharge to surface in the vicinity of the clay contact, providing baseflow to area tributaries; and

6. The majority of precipitation falling within the eastern half of the subwatershed, will become runoff, however the limited precipitation that does infiltrate is expected to discharge to local tributaries.

Figure 7 - Conceptual Hydrostratigraphy (modified after NPCA, 1999, section numbers are explained in Section 3.5)

The Port Robinson Subwatershed Study (NPCA, 1999) previously described the hydrostratigraphy as follows (the numbered bullets below correspond with the numbers on schematic Figure 7 as modified from NPCA, 1999):

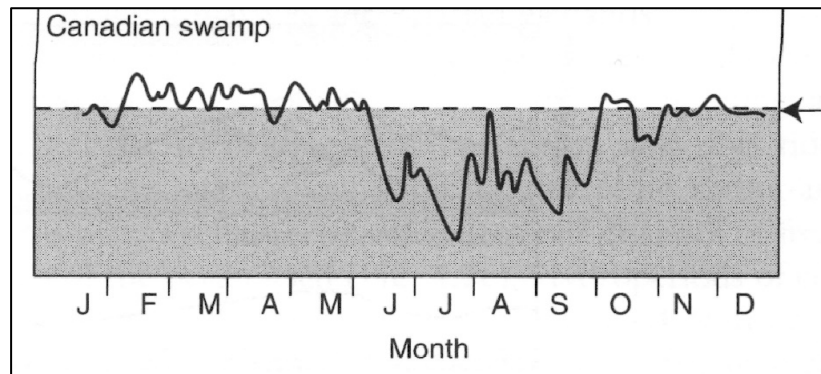
Figure 14 – Canadian Swamp Hydroperiod (Mitsch and Gosselink, 2007)

Note: arrow indicates wetland ground surface

Mitsch and Gosselink (2007) report that the *“hydroperiods of many bottomland hardwood forests and swamps have distinct periods of surface flooding in the winter and early spring due to snow and ice conditions followed by spring floods but otherwise have a water table that can be a meter or more below the surface”* (Figure 14), this characterization appears reasonable for the wetlands at the Site.

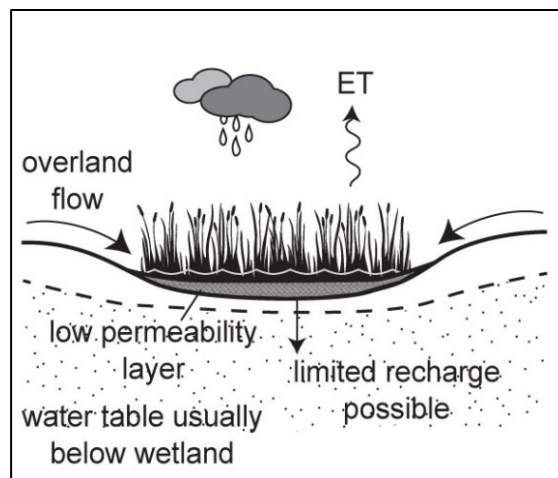
Figure 15 - Surface water depression wetland (Mitsch and Gosselink, 2007)

The wetlands are proposed classified as a *surface water depression wetlands* (Figure 15) (Mitsch and Gosselink, 2007).

A surface water depression wetland is summarized as a: “*wetland...dominated by surface runoff and precipitation, with little groundwater outflow due to a layer of low-permeability soils...*”. Low permeability silty clay soils have been noted beneath the wetlands as per this description.

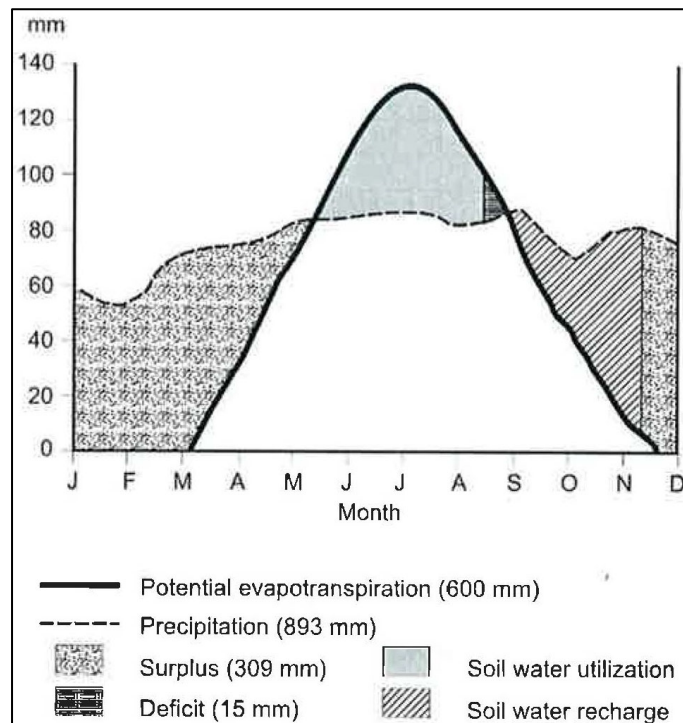
Figure 16 – Brantford Average Water Balance (Sanderson, 2004)

An example of water balance modelling from the University of Waterloo is shown below (Figure 16). Annual groundwater recharge begins in the fall following 'soil water utilization' and 'deficit' in the summer. Soil water utilization corresponds with evapotranspiration exceeding the precipitation supply. Annual groundwater recharge occurs during the same time period that groundwater levels rise. However, in this example it is noted that the soil water holding capacity (SWHC) modelled was only 100 mm compared to the higher SWHC 350 to 400 mm for the on-site wetlands (Section 3.6.3) which retain a greater amount of water.

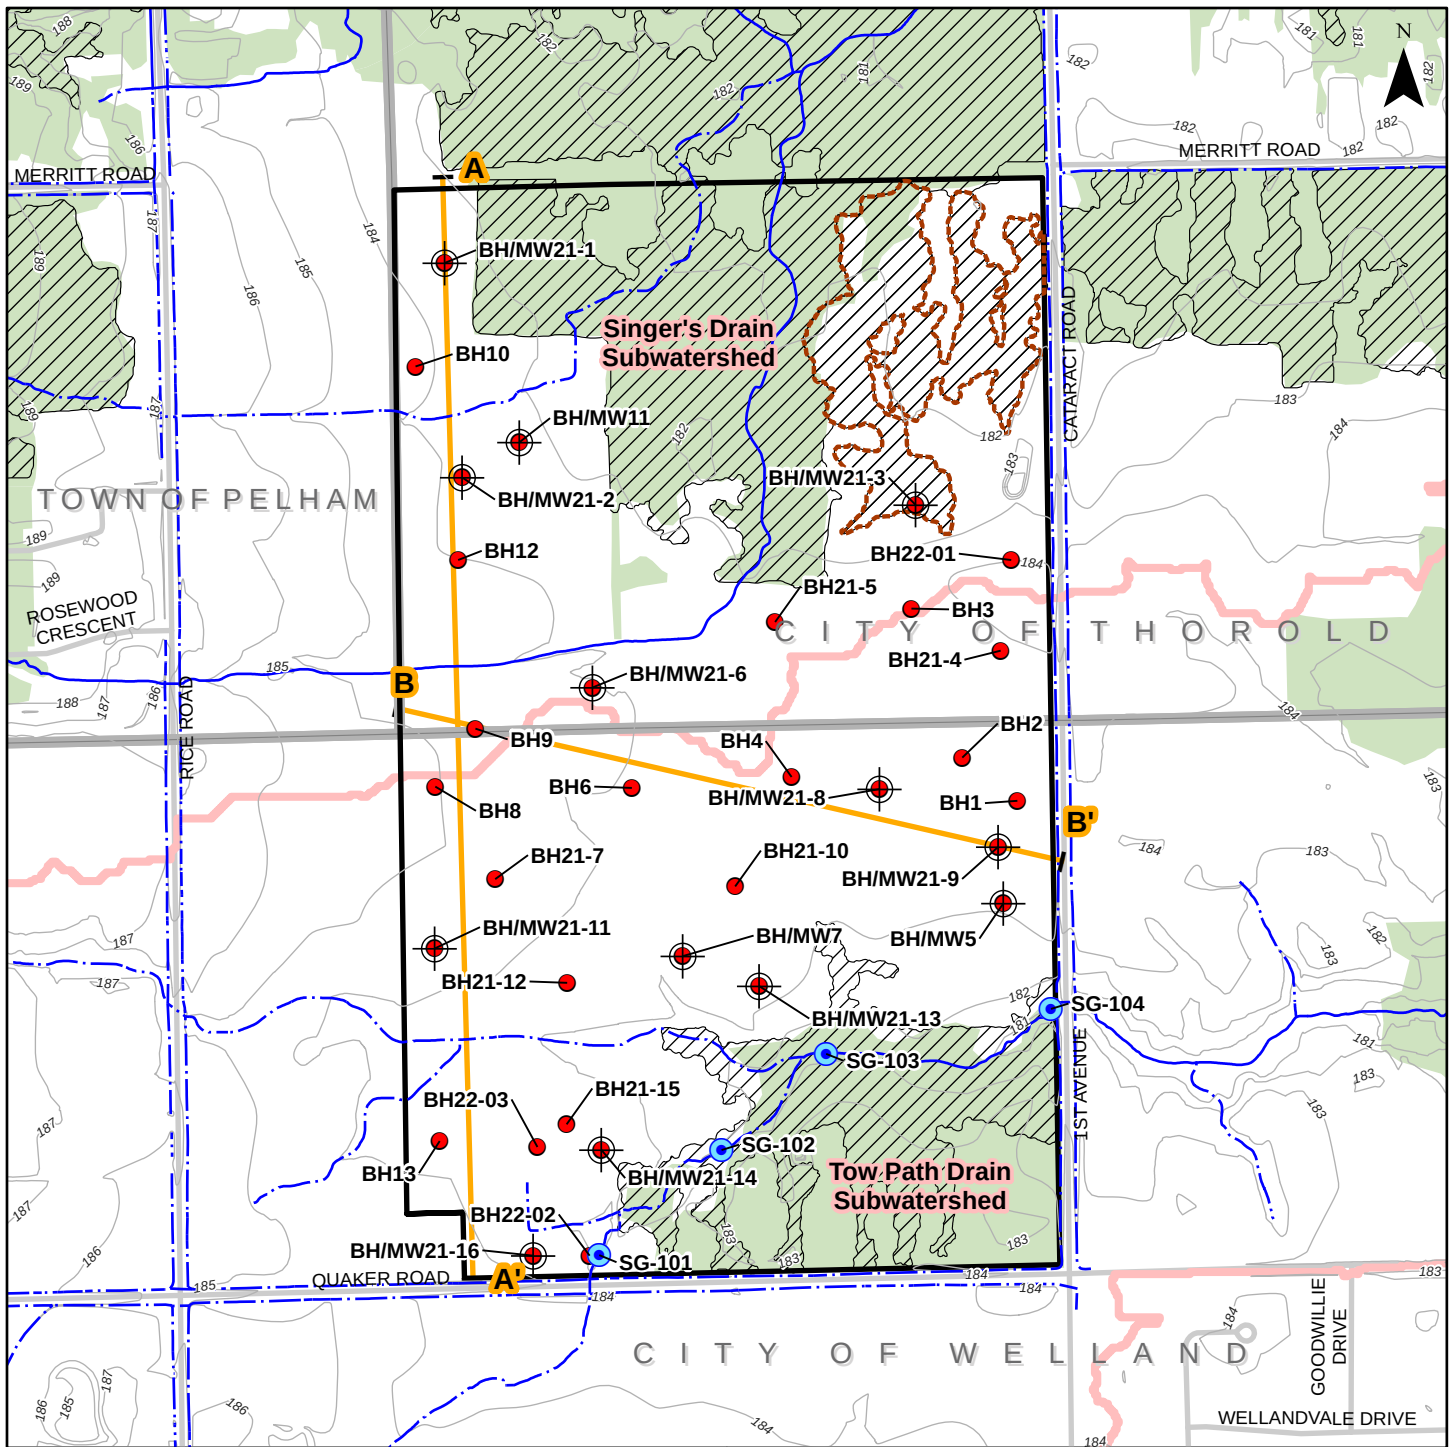
Figure 2

## Site Details

The Ministry of Natural Resources and Forestry (MNRF) have mapped at the Site approximately 17 hectares of Provincially Significant Wetland (PSW) associated with the Niagara Street Cataract Road Woodlot Wetland Complex (MNRF, 2009), this includes (Figure 2, see attachments):

1. 5.2 hectares of swamp along Quaker Road and First Avenue in the southeast corner of the Site,
2. 8.2 hectares of swamp in the northern portion of the Site, and
3. 3.6 hectares of marsh in the northeast corner of the Site close to Cataract Road.

A series of four surface water staff gauges (SG-101, SG-102, SG-103 and SG-104) were installed on-site along Tow Path Drain in August 2023 (Figure 2, see attachments and Appendix F) and equipped with water level datalogger pressure transducers recording at 15-minutes intervals. The surface water monitoring was completed in addition to the original Terms of Reference (Appendix A). Clayey soils were observed beneath Tow Path Drain during the installation of the gauges via hand-augering completed to between 0.7-0.8 metres below ground surface. During the monitoring period (i.e. mid-August to mid-November 2023) August monthly precipitation was well-above average, while September, October and November monthly precipitation were well-below average (Table 1, see attachments). Water level monitoring of Tow Path Drain indicated surface water is only present intermittently as shown by dry conditions following precipitation events (Appendix F). Nearby groundwater levels were below ground surface during this monitoring period (BH21-13 and BH21-14) further confirming no groundwater discharge to surface water and an intermittent surface water classification consistent with other’s investigations. Water levels at the nearby wetlands were observed to rise following precipitation events (Appendix C). After precipitation events, the water levels at nearby wetlands responded one of two ways:

The Site includes 17 ha of the Provincially Significant Niagara Street Cataract Road Woodlot Wetland Complex (MNRF, 2009), mapped to cover 27% of the Site (Figure 2, see attachments). The MNRF have described that the *“dominant wetland type ... (is) swamp, situated through a slough forest ecosystem. A slough forest ecosystem is characteristic of the Haldimand and Niagara Clay plain physiographic regions and consists of shallow to deep depressions...”* (MNRF, 2009). It is noted an area of marsh was also mapped by the MNRF in the northeast corner of the Site. General information regarding the Provincially Significant Wetlands mapped by the MNRF at the Site are summarized in Table 7. For example, the wetlands have been mapped as Palustrine wetlands, based upon having intermittent or no inflow, and either permanent or intermittent outflow and may rely on rainfall and some overland flow (MNRF, 2014).

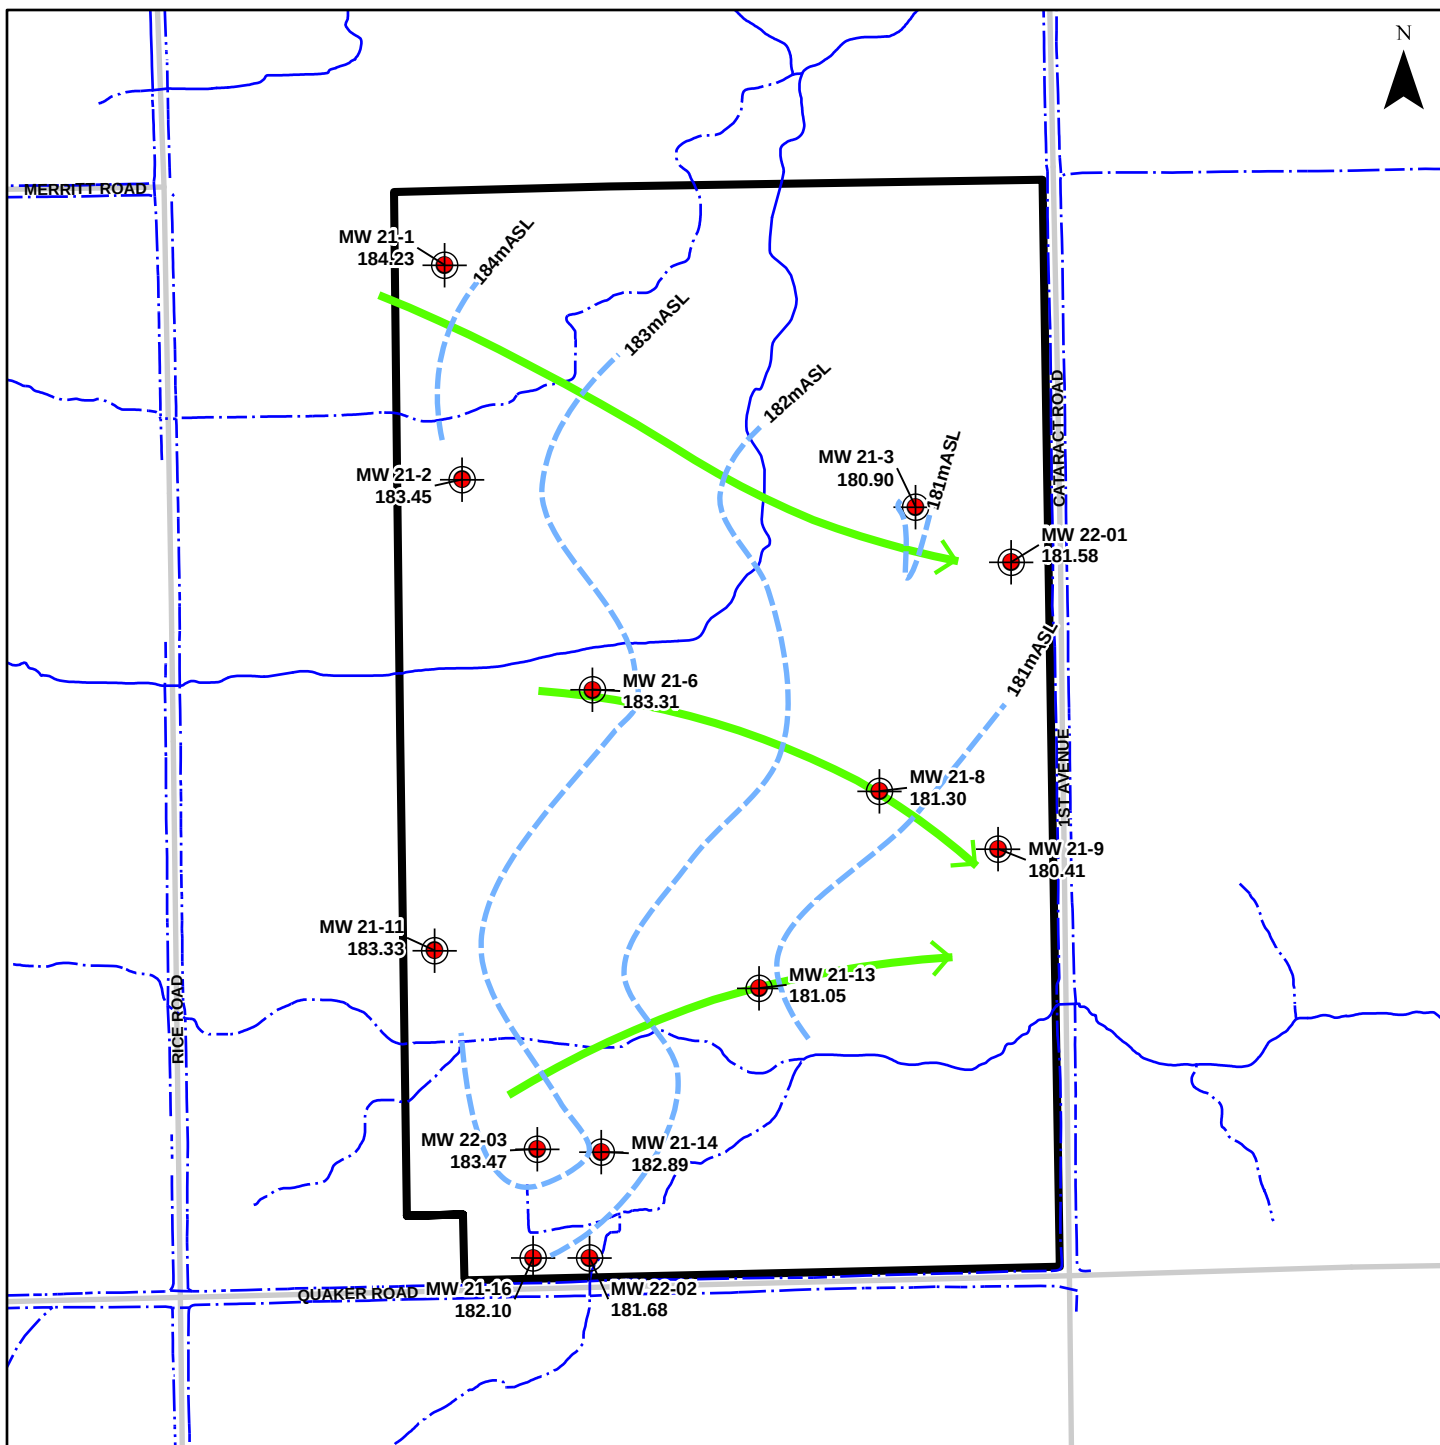
**Figure 8**

- Subject Lands
- Monitoring Well Location and Groundwater Elevation (m ASL)
- ➔ Groundwater Flow Direction
- Water Table Elevation Contours (mASL)
- NPCA Watercourse Permanency**
  - Ephemeral
  - Intermittent or Ephemeral

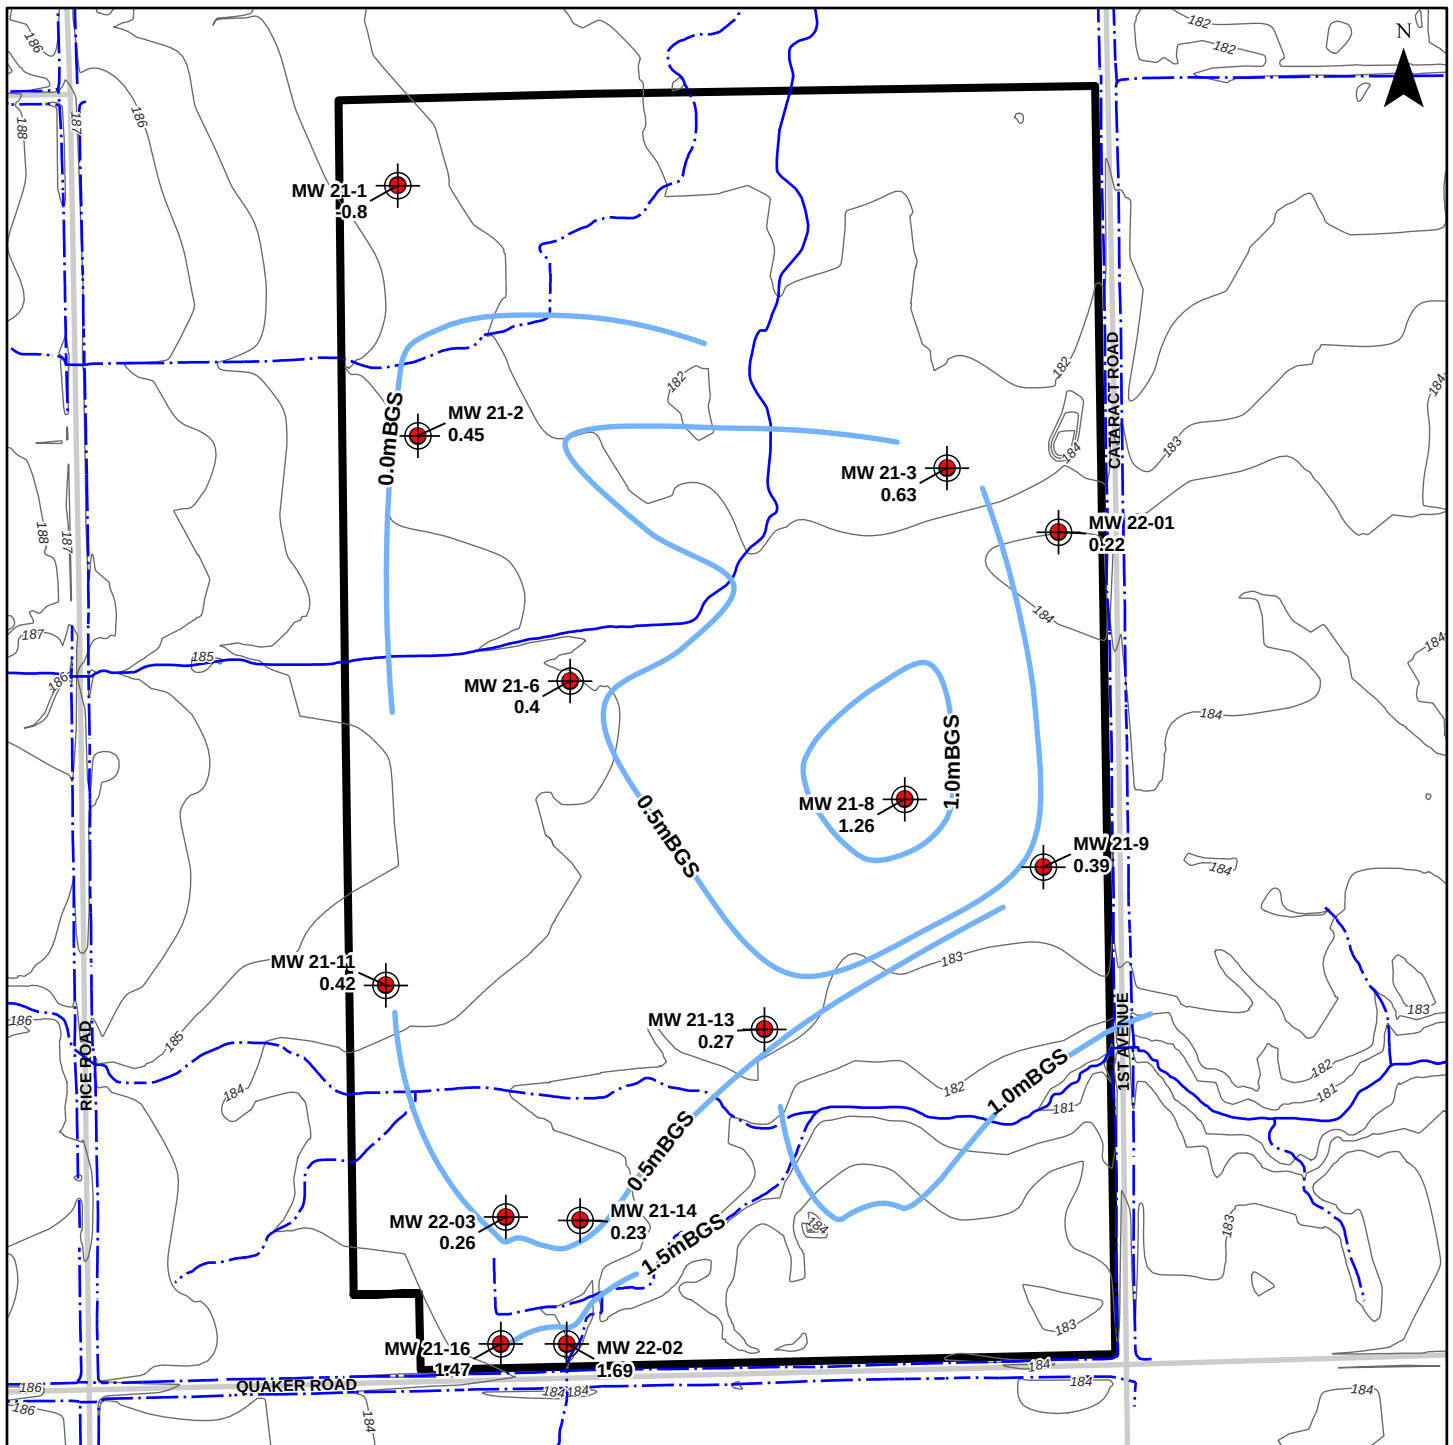
**Figure 9**

- Subject Lands
- Monitoring Well Location and Depth to Water Table (m)
- Depth to Water Table (mBGS)
- Ground Surface Contour (NPCA)
- NPCA Watercourse Permanency**
- Ephemeral
- Intermittent or Ephemeral

The 'spring-high' groundwater levels were measured very close to surface in April, 2023 as generally less than 1 m BGS (Figure 9, see attachments). In August, 2022, the depth to groundwater increased across the Site from west to east from ~1 m BGS to 2.5 m BGS despite '*Abnormally dry to moderate*' drought climate conditions reported by Agriculture Canada (2023) for August 2022.

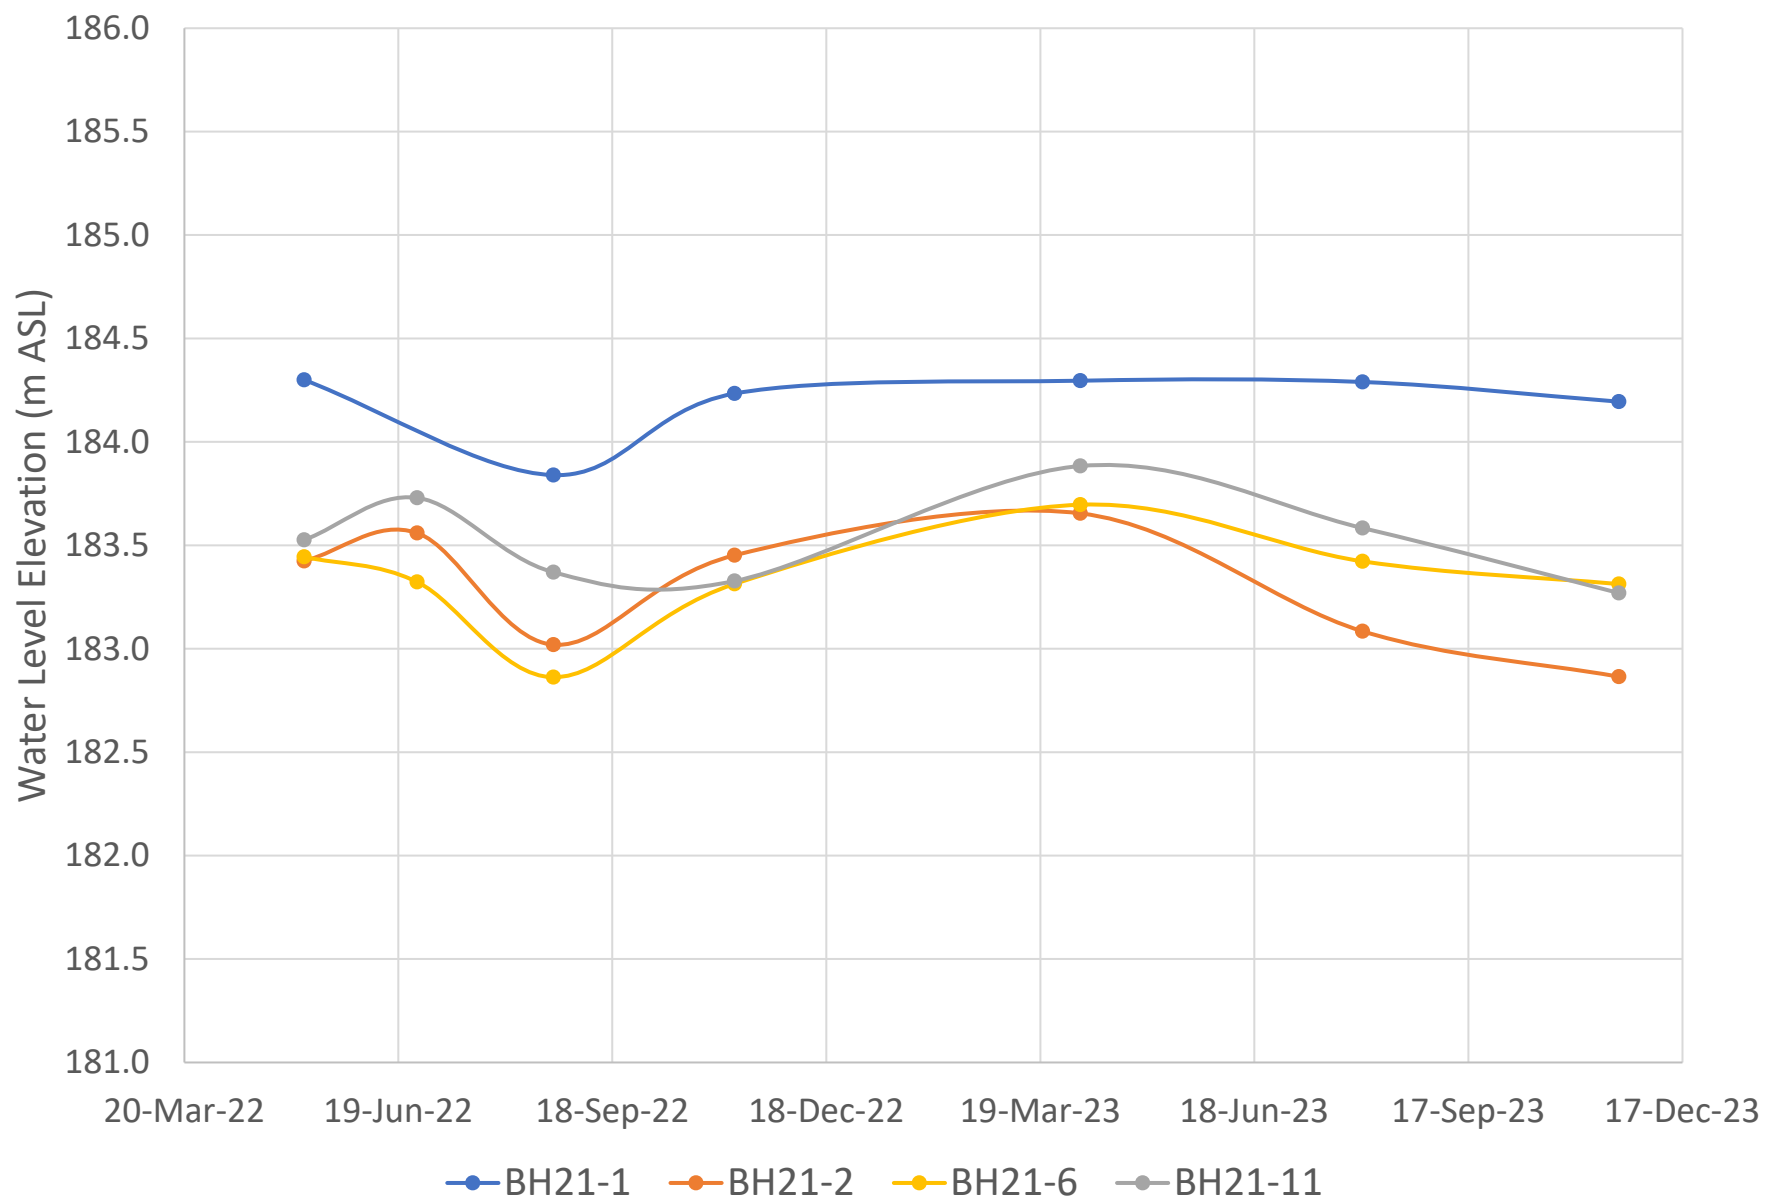
**Figure 10 - Western Upgradient Manual Groundwater Levels**

The greatest seasonal groundwater level variations were noted for the downgradient monitoring locations, while less seasonal variation was noted for the upgradient western locations (Figures 10, 11 and 12, see attachments). Dampened seasonal variation for the upgradient western locations is inferred to be as a result of horizontal groundwater recharge from the Fonthill Kame-Delta Complex Recharge Area to the Site. Observations from the groundwater levels include:

- i. Monitor MW21-01 (west/upgradient): The groundwater level in the monitoring well was consistently above ground surface, at above 184.3 m ASL except during the summer and early fall seasons, however, there were not ponded conditions at surface. With only about 0.5 m of seasonal

change from spring to August 2022, it is believed the fine sand seams noted on the borehole log receive lateral recharge from the Fonthill Kame-Delta Complex as limited drawdown only occurred during the summer growing season.

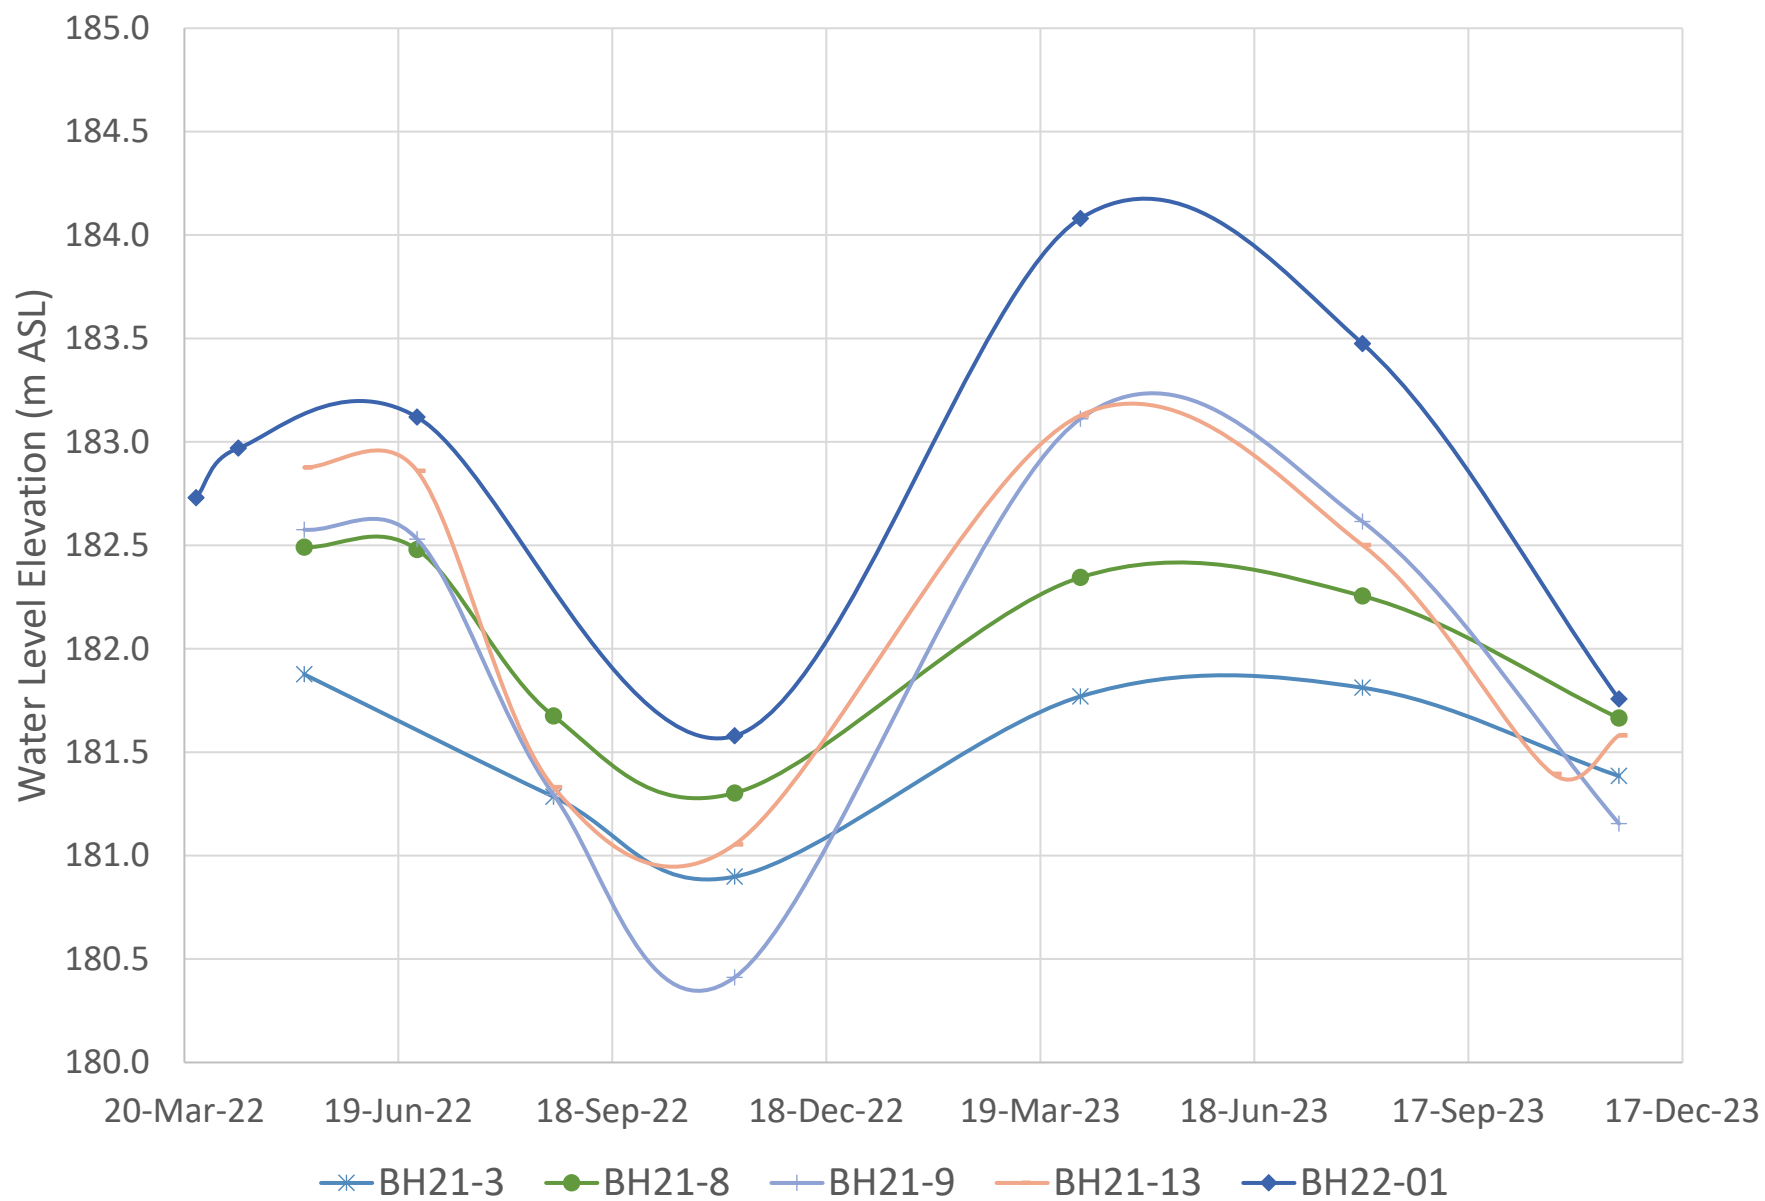
**Figure 11 - Eastern Downgradient Manual Groundwater Levels**

- ii. Monitor MW21-13 (located mid-site): The groundwater level showed a distinct seasonal decline of about 2.5 m from the spring season to October 2022, with groundwater level recovery beginning in the fall season of 2022, with some responsiveness to precipitation noted.
- iii. Monitor MW21-03 (located downgradient/east): A seasonal decline of groundwater levels of about 1 m from spring to October 2022, with groundwater level recovery beginning in the season of fall 2022 with limited responsiveness to precipitation events.
- iv. Monitor MW21-14 (located in the southwest): A seasonal decline of groundwater levels of about 1.5 m from the spring season to August/October 2022, with groundwater level recovery completed before winter 2023, and was very responsive to precipitation events.

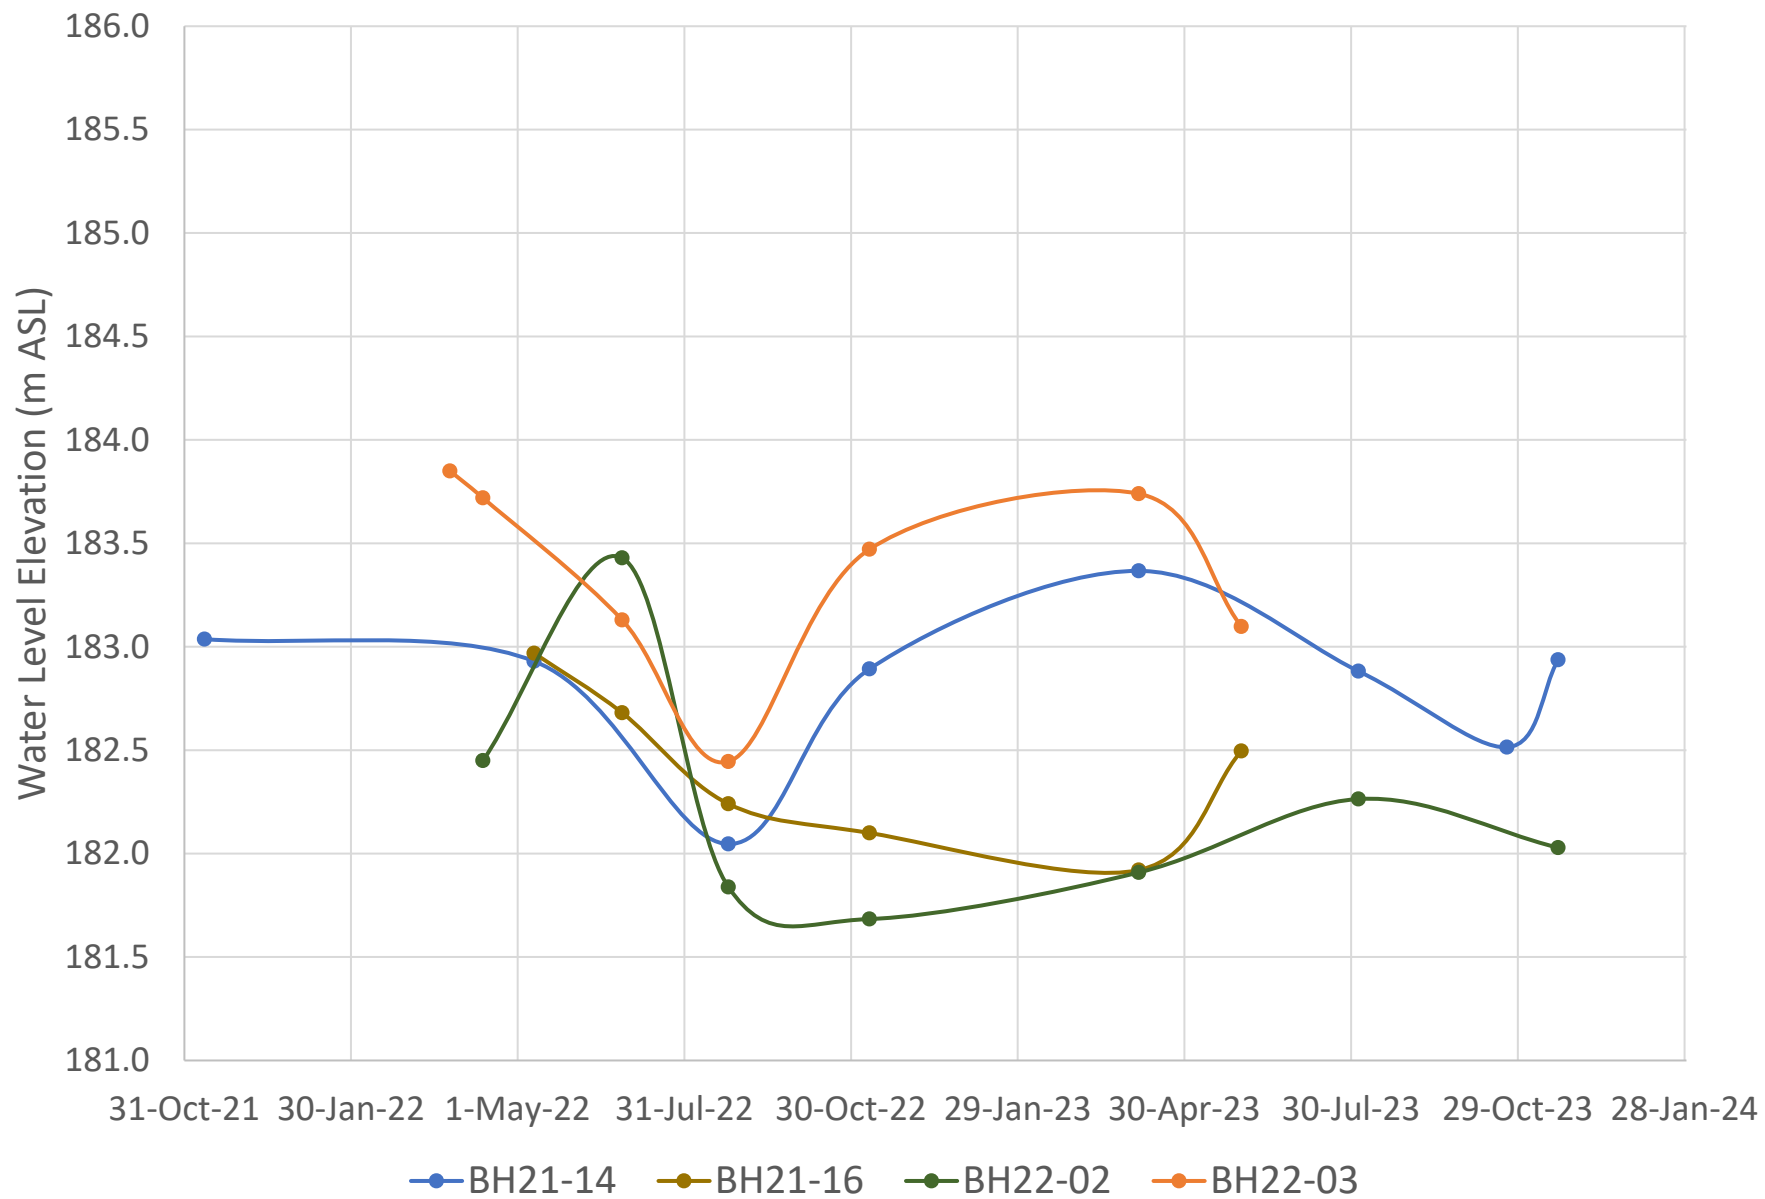
Figure 12 - Southwest Manual Groundwater Levels

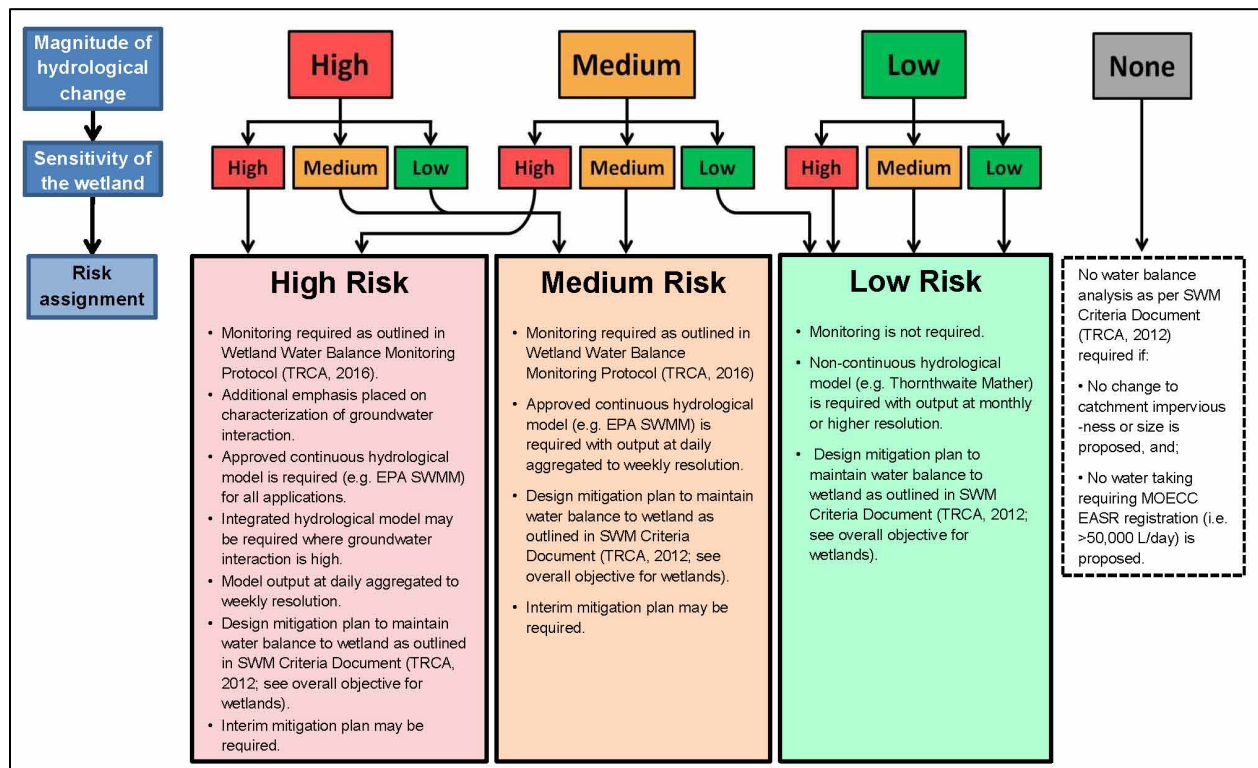
Figure 2 – Wetland Risk Evaluation Decision Tree (TRCA, 2017)

As per Figure 17, a medium risk is assigned based upon (i) either a high or medium magnitude of hydrological change, and (ii) a medium wetland sensitivity. The TRCA recommended study, modelling and mitigation requirements are:

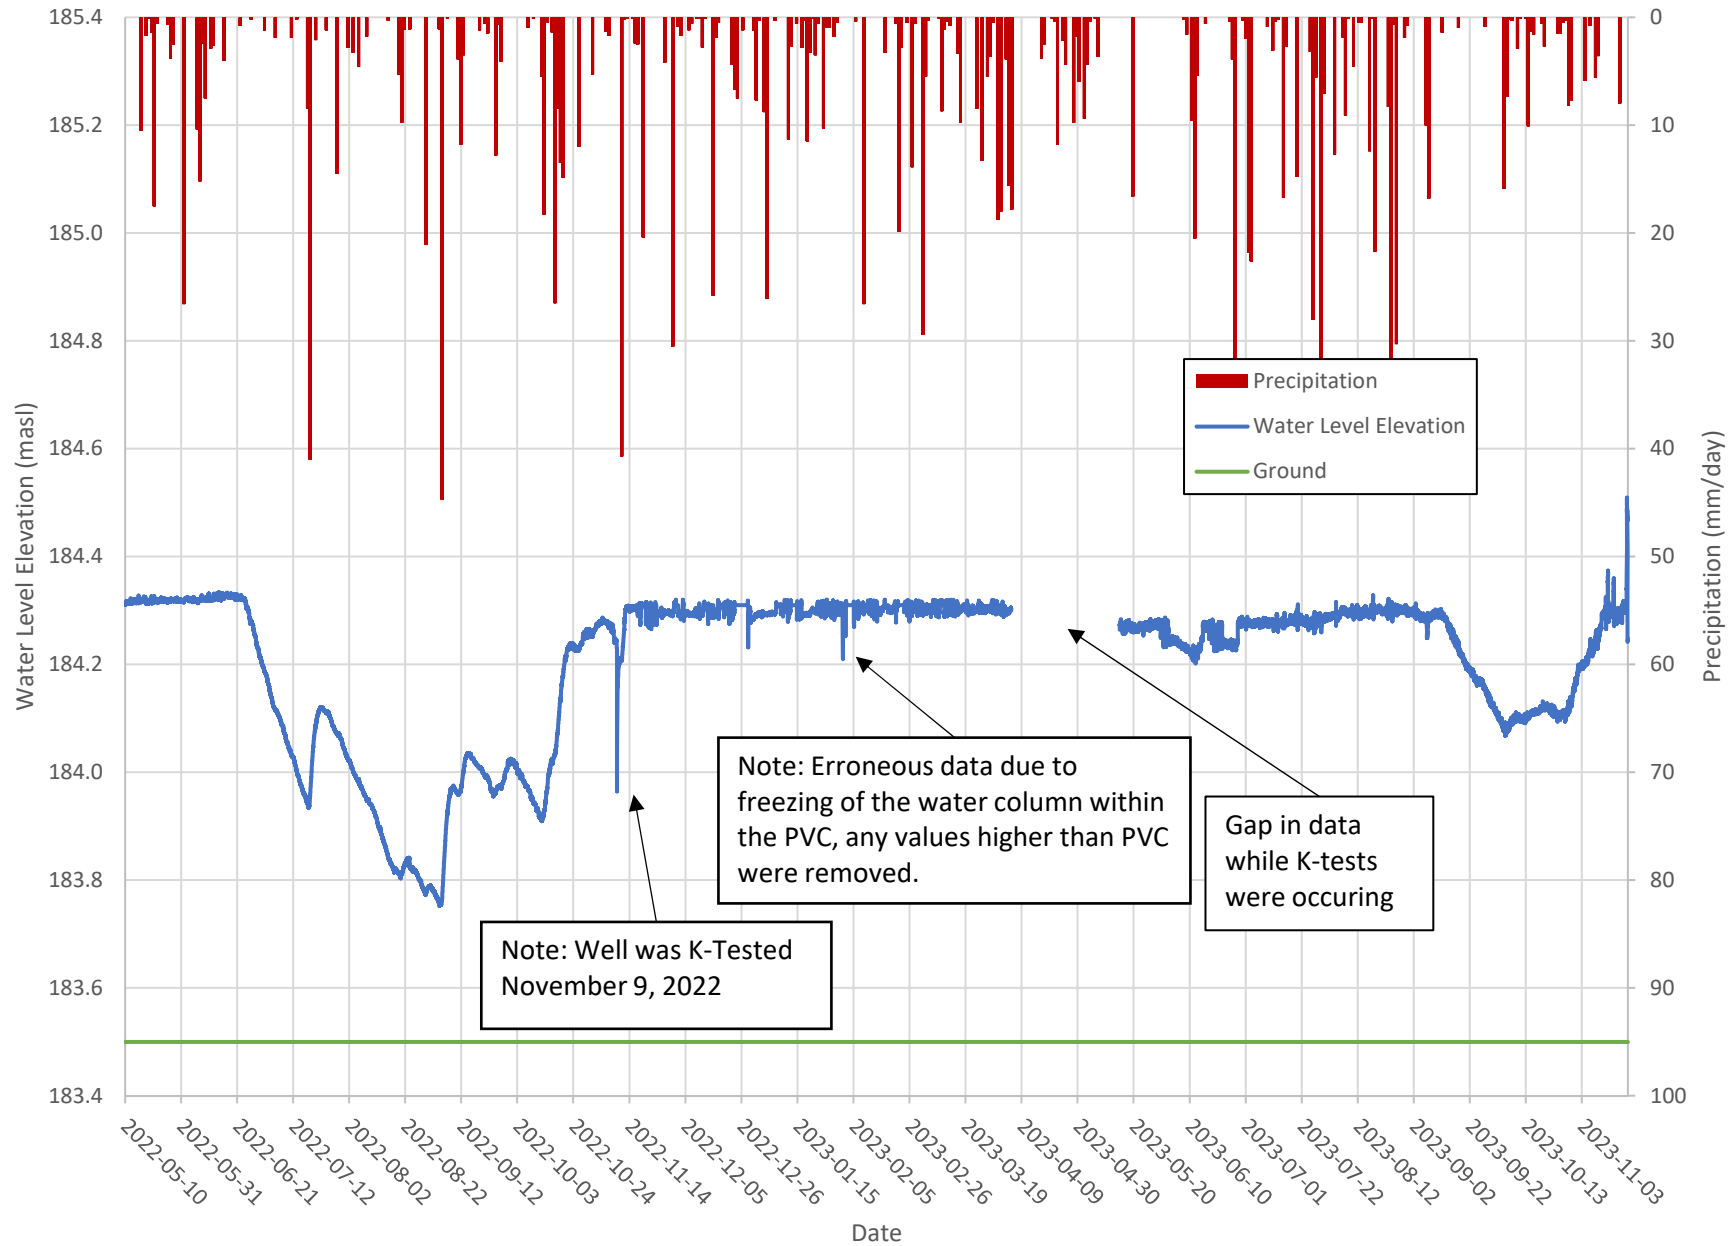
Primont BH21-01 Water Level Elevation vs. Precipitation from May 10, 2022 to November 17, 2023

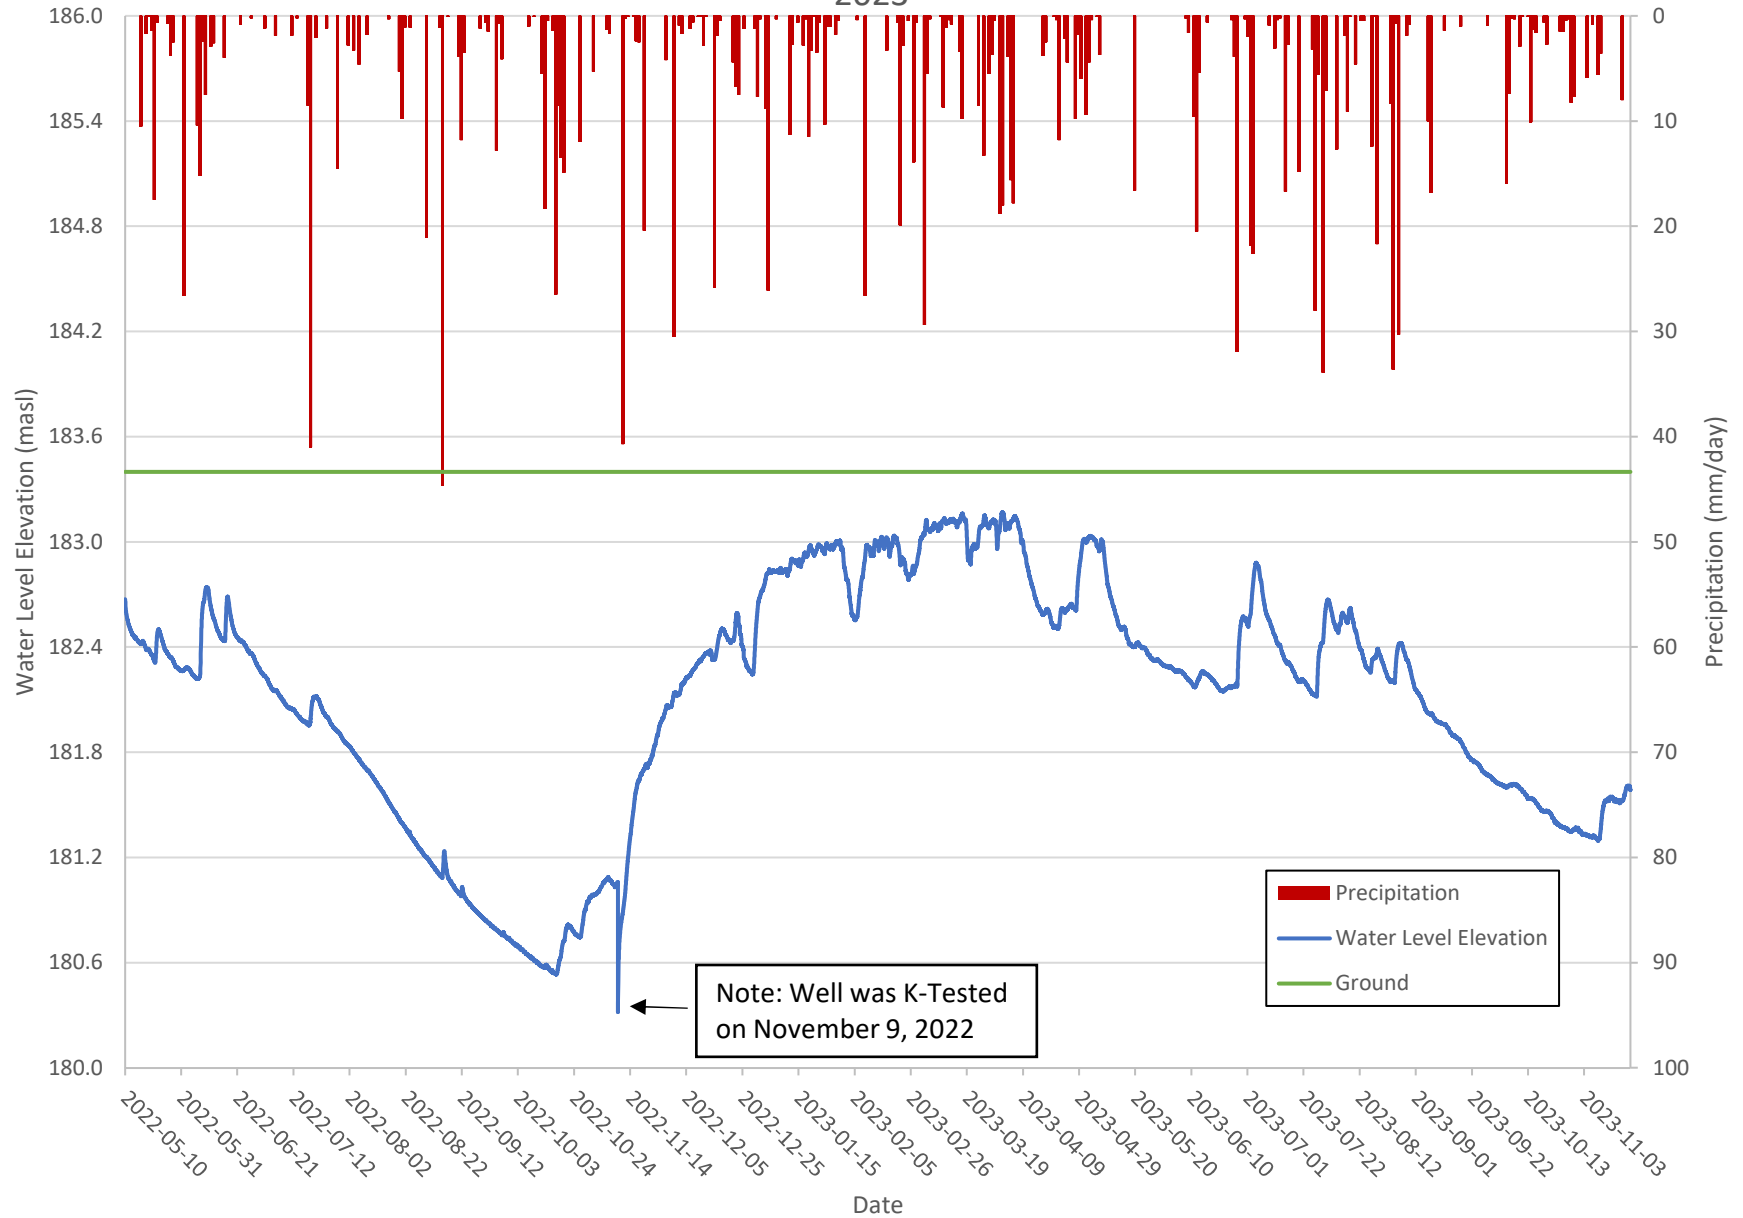
Primont BH21-13 Water Level Elevation vs. Precipitation from May 10, 2022 to November 17, 2023
