# **Terra-Dynamics Consulting Inc.**

Re: Hydrogeologic Study and Wetland Water Balance, 436 Quaker Road, Welland,  
and Lot 228/Part Lot 174, Thorold, ON

Terra-Dynamics Consulting Inc. respectfully submits this DRAFT Hydrogeologic Study and Wetland Water Balance of 436 Quaker Road Welland, and Lot 228/Part Lot 174, Thorold (the Site, Figure 1, see attachments). The rectangular 60.8 hectare Site is located at the northwest corner of Quaker Road and First Avenue, within both the City of Welland (southern part of Site) and south of an unopened Merritt Road allowance within the City of Thorold (northern part of Site) (Figures 1 and 2, see attachments). This report has been completed as part of planning for future residential development of the currently agricultural lands. No tile-drainage is mapped for the Site (OMAFRA, 2023).

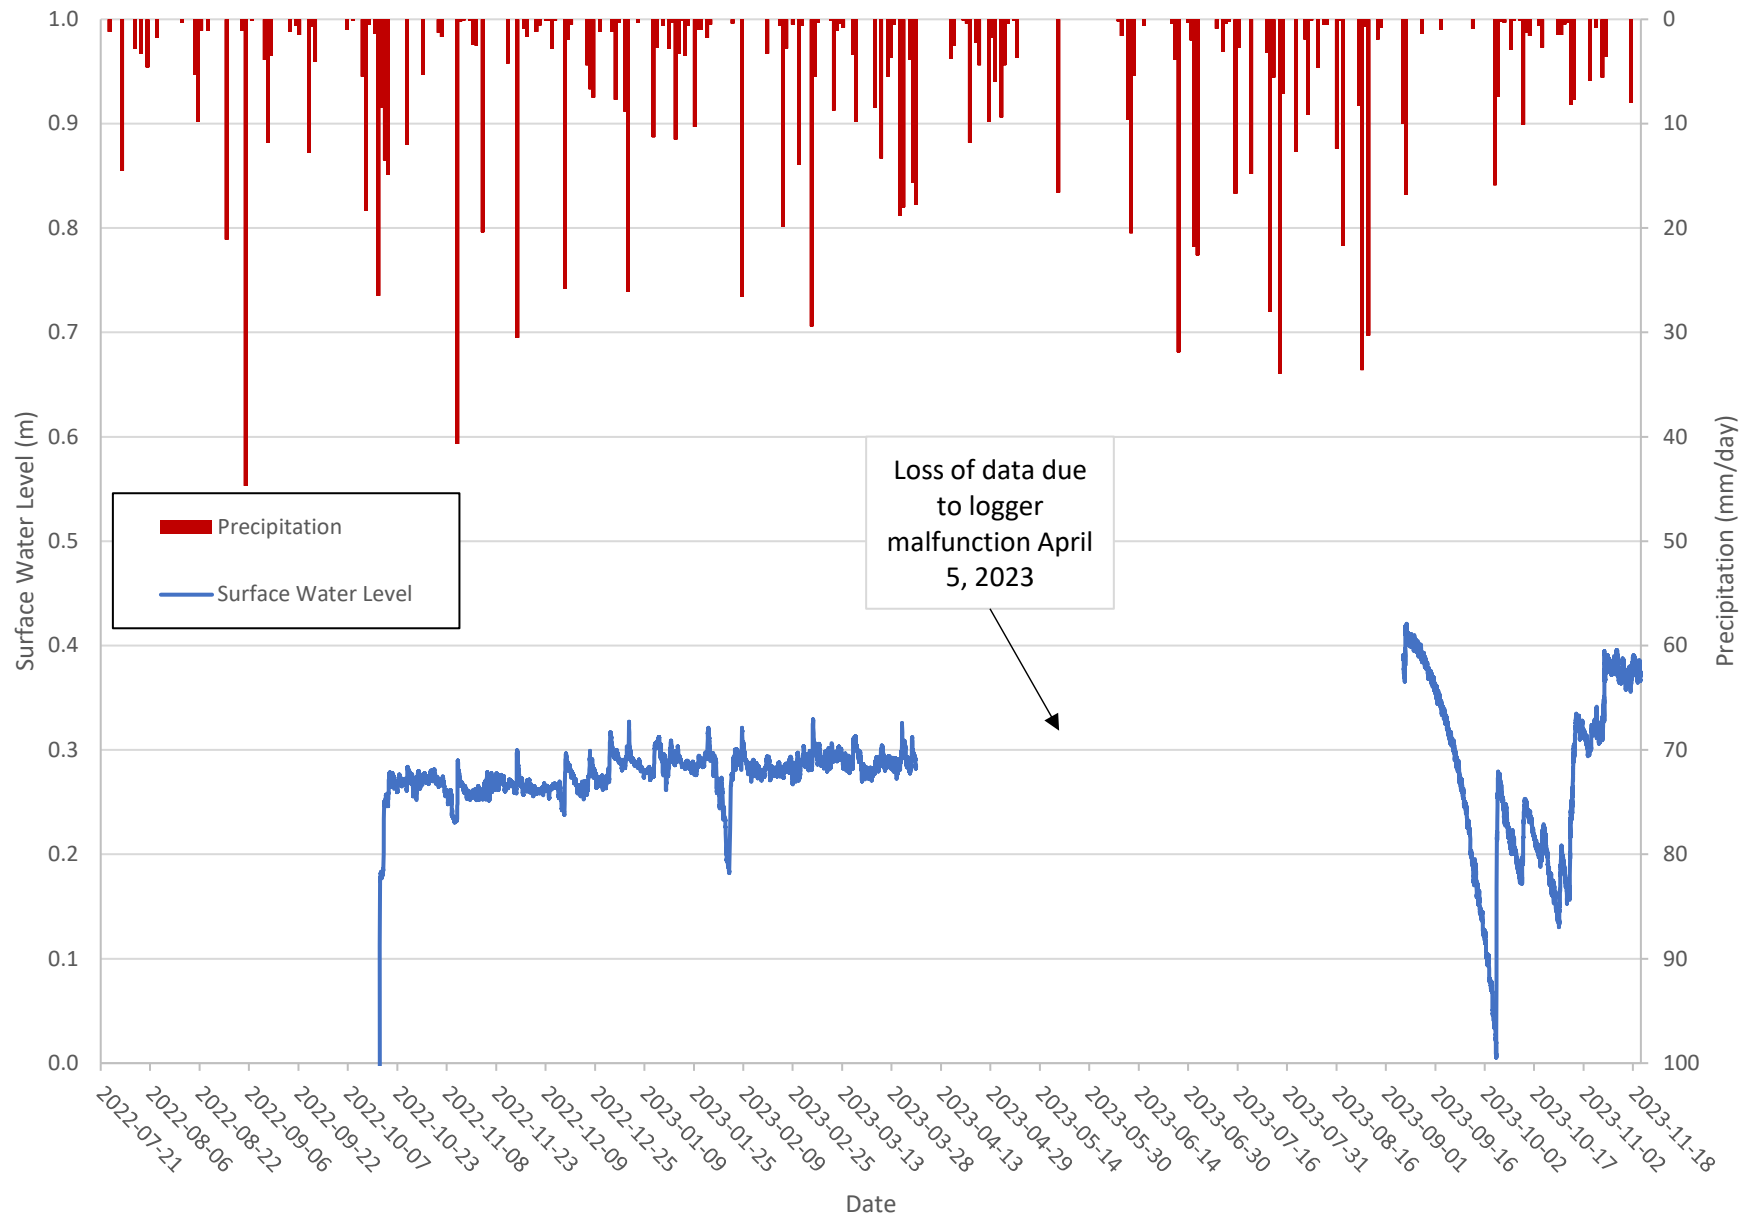
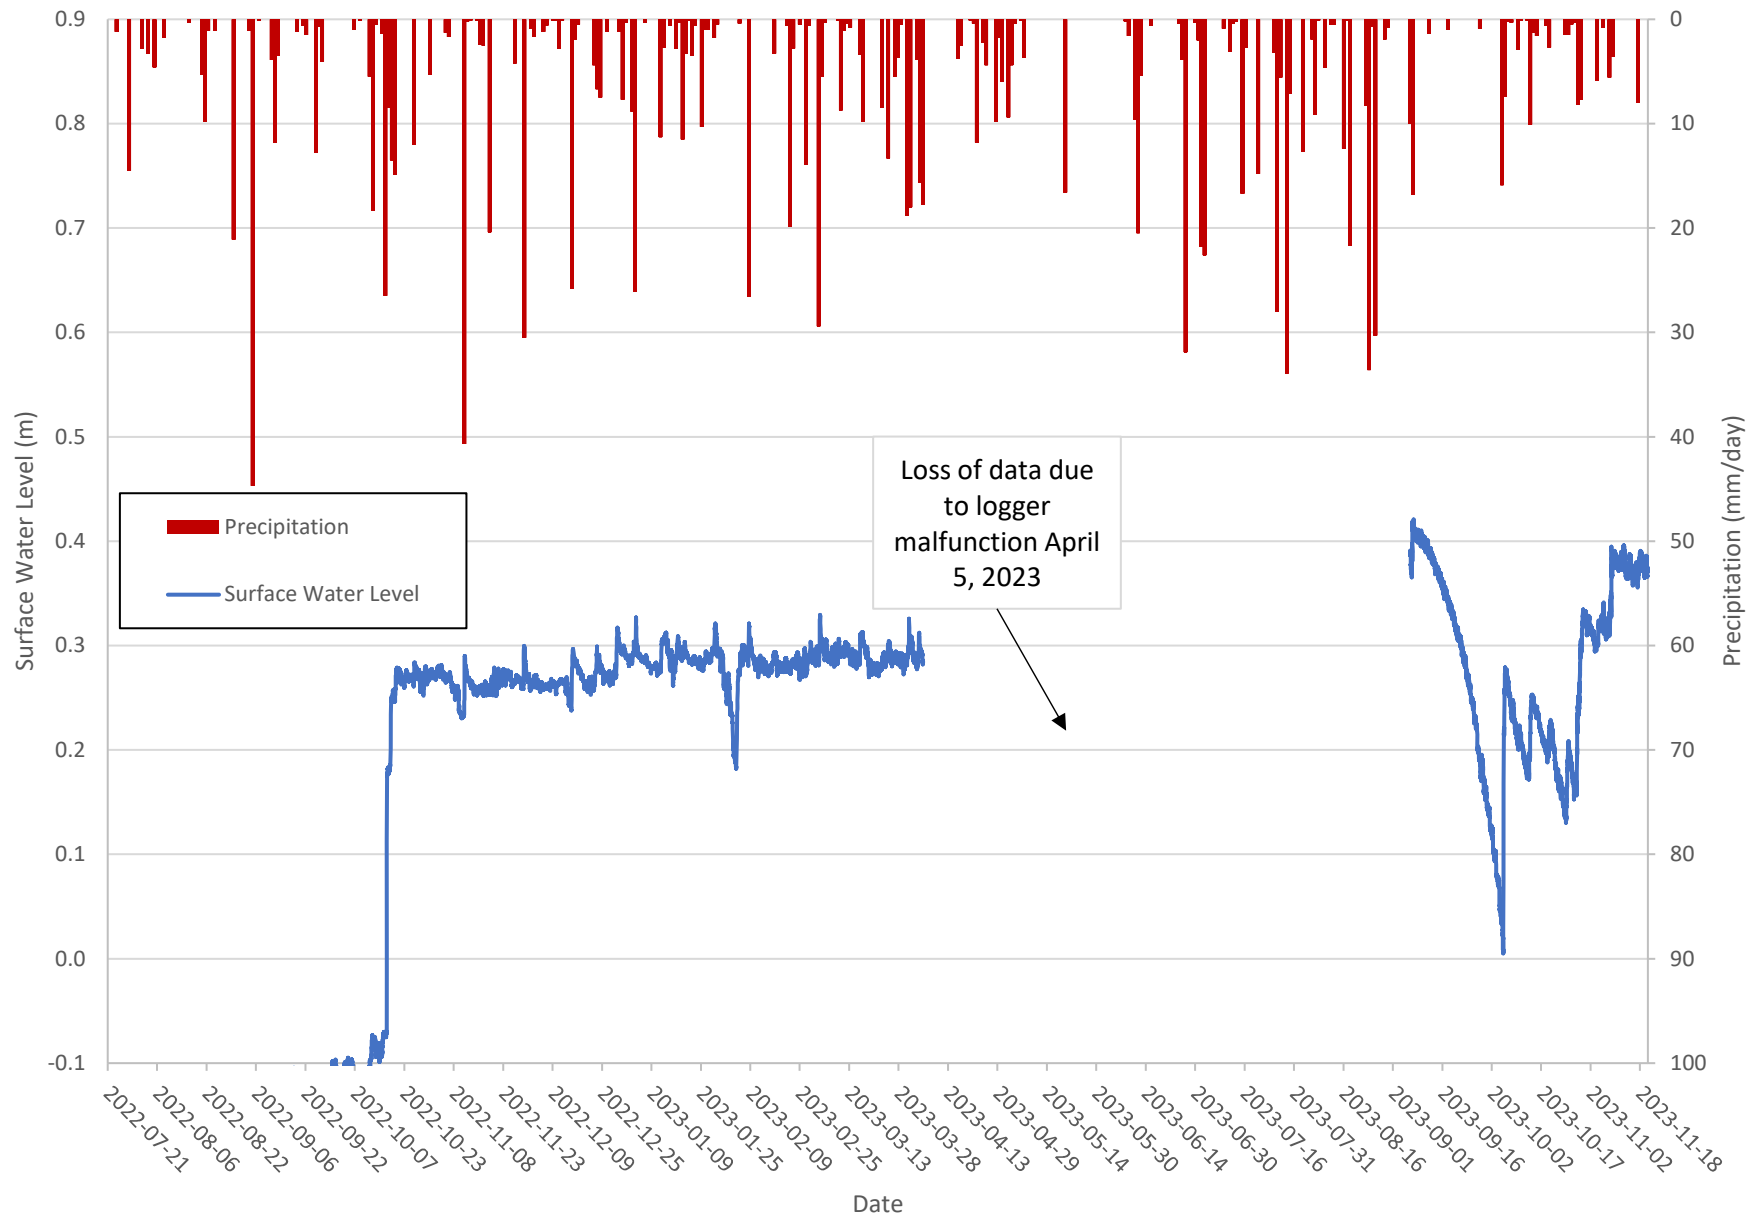
Primont SW-1 Surface Water Level vs. Precipitation from July 21, 2022 to November 20, 2023

The observed wetland hydrographs at the Site were fairly similar in overall patterns over the July 2022 to November 2023 monitoring period (Appendix E). These perched surface water level patterns are summarized below:

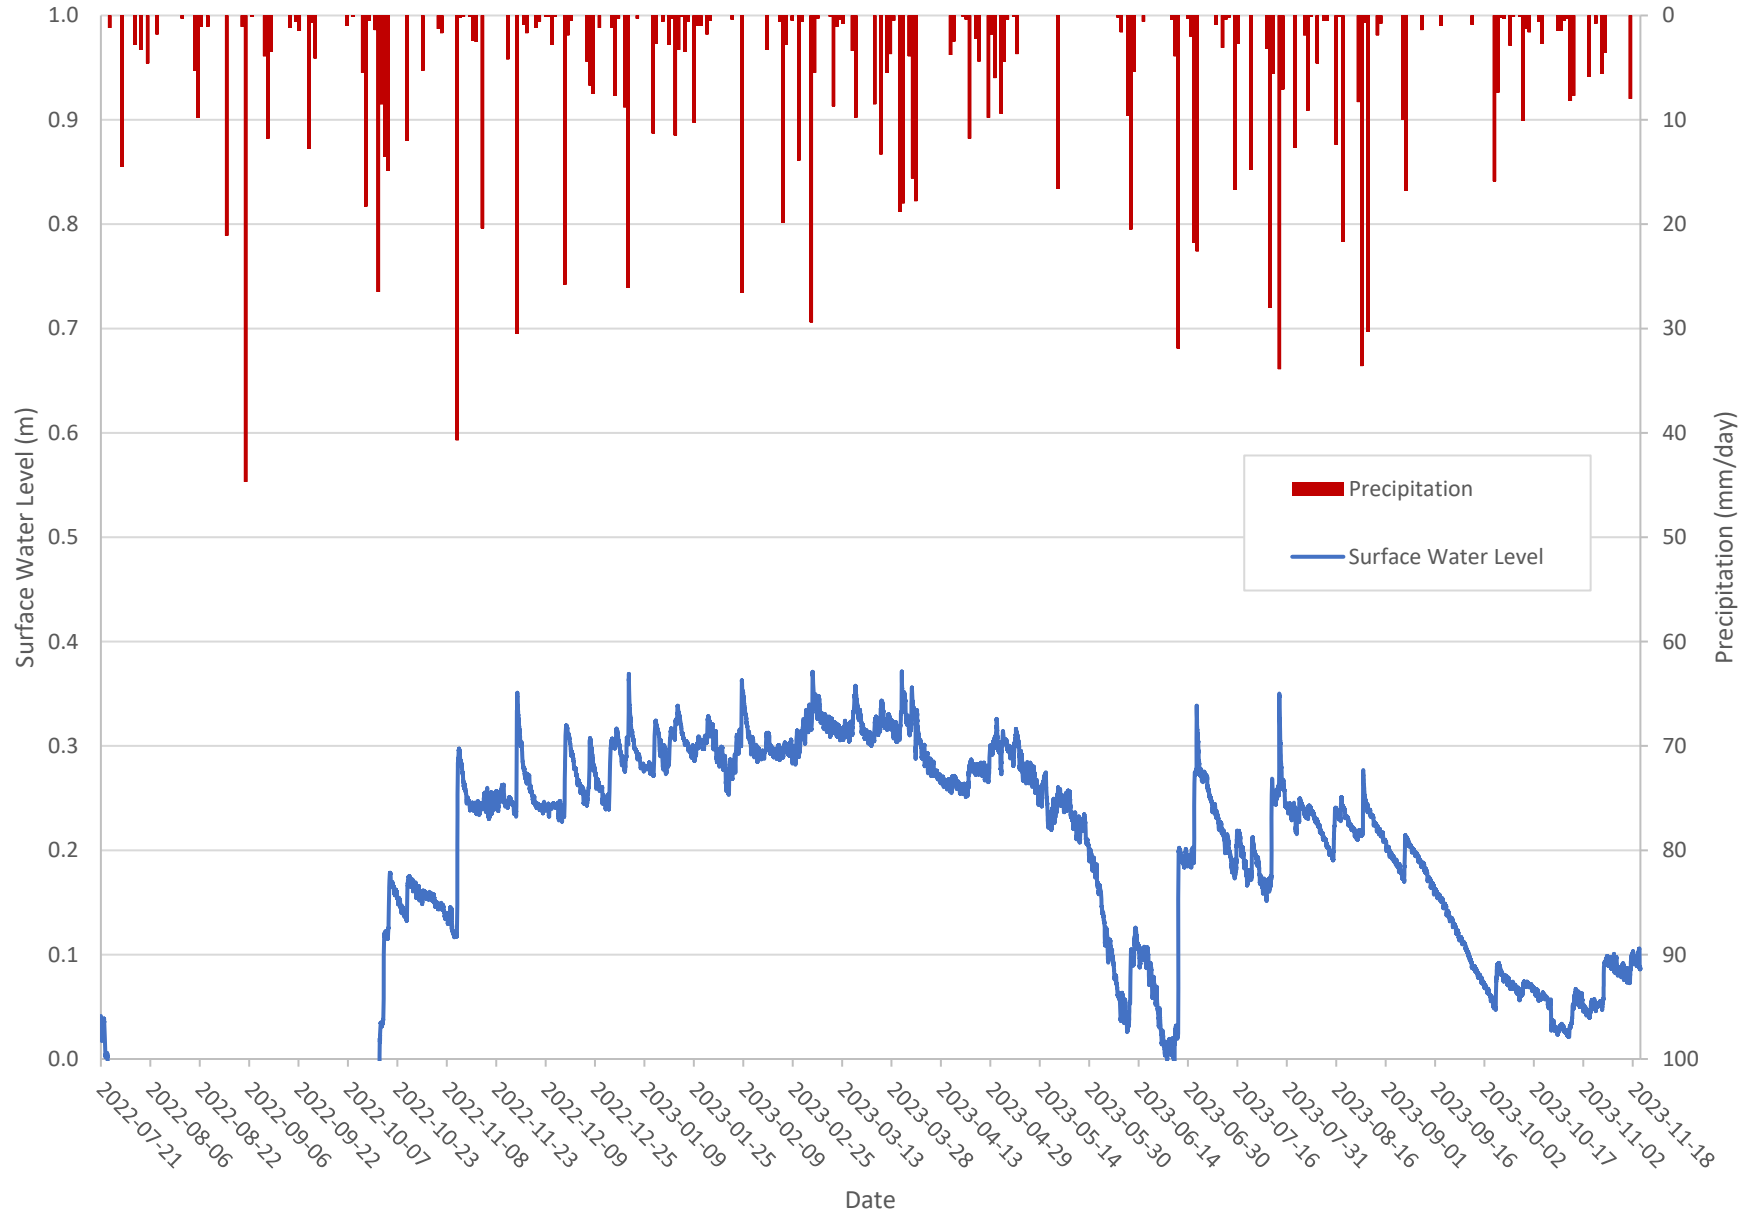
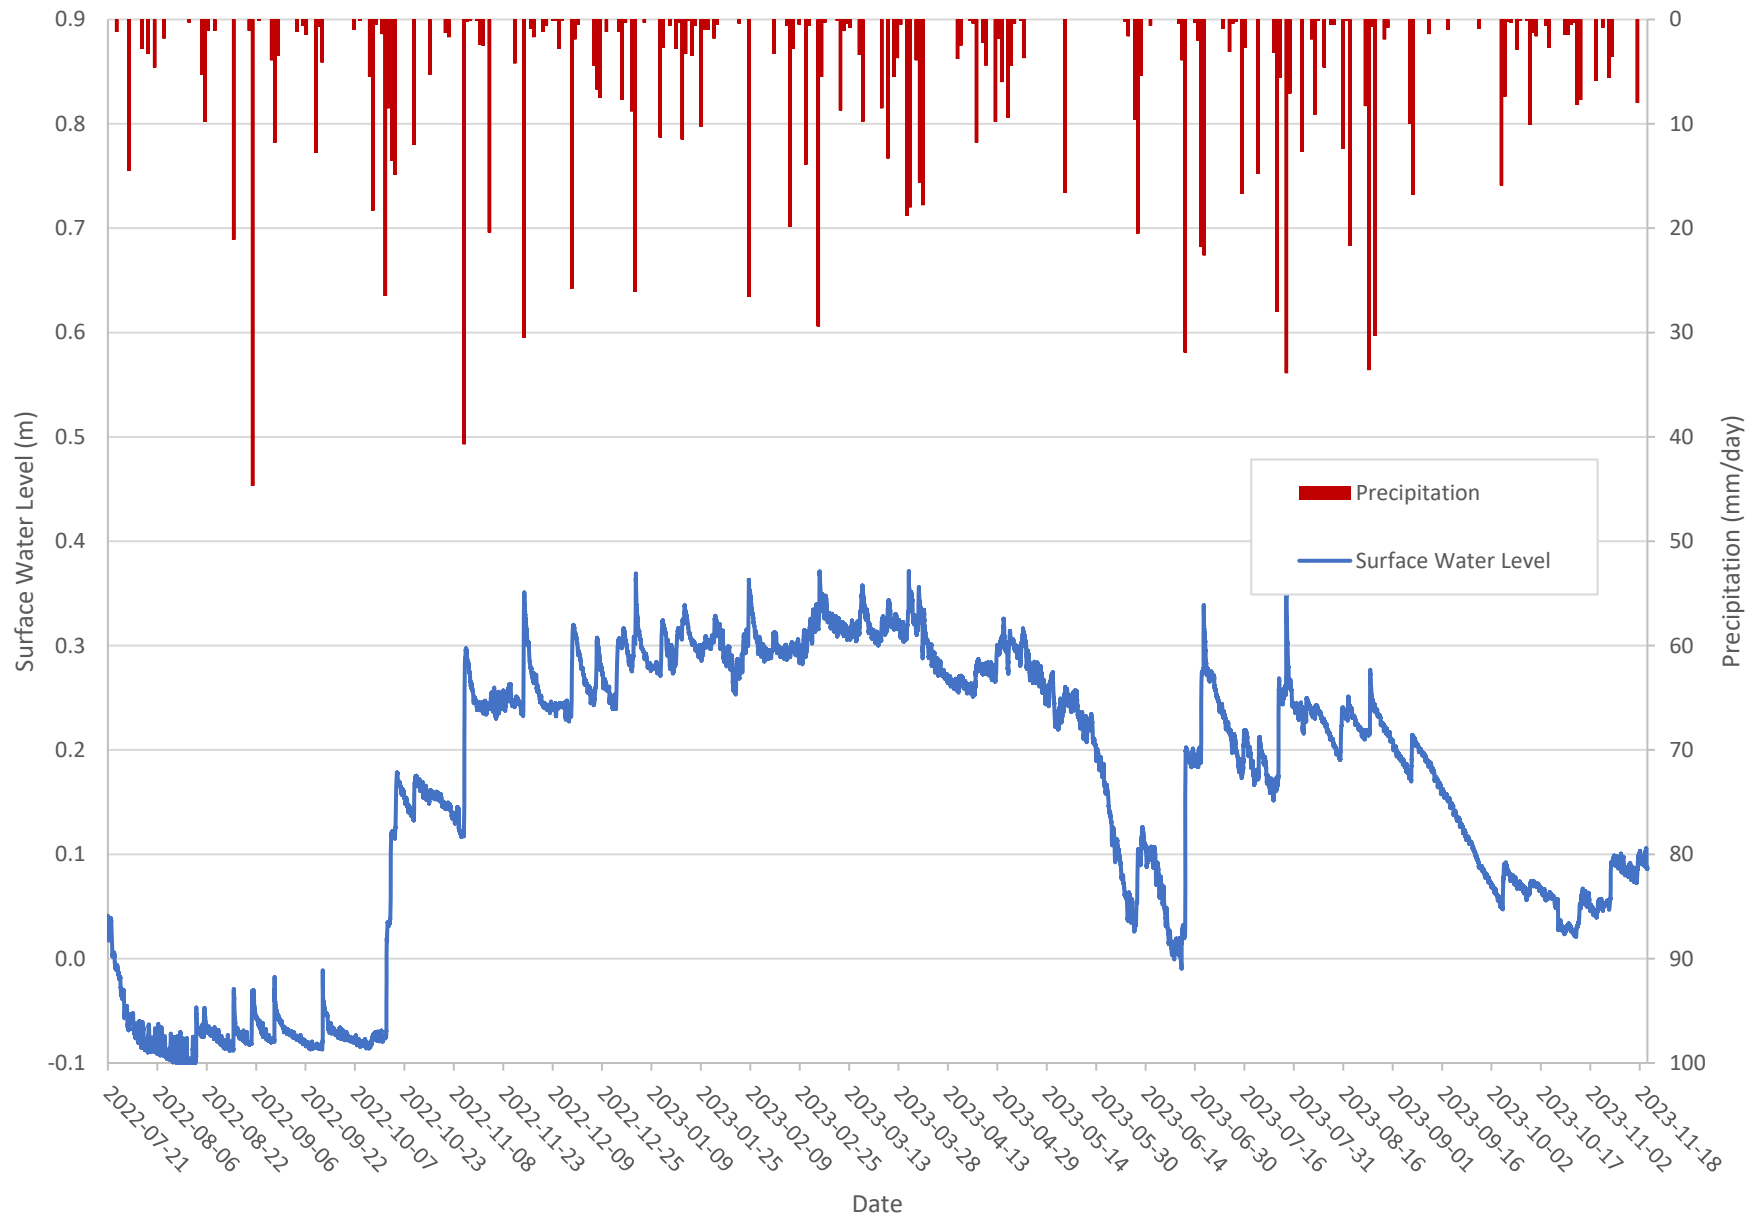
Primont SW-6 Surface Water Level vs. Precipitation from July 21, 2022 to November 20, 2023

- (i) Where generally water depths were 10 cm or less, diurnal evapotranspiration water level fluctuations and dry/intermittent conditions after rain events (SW-2, SW-3, SW-4, SW-5 and SW-9); or
- (ii) Where water depths were greater than 10 cm, diurnal transpiration fluctuations overlaid on a gradual decline, similar to predicted evaporation rates (Schroeter & Associates, 2007) (SW-6 and SW-8).

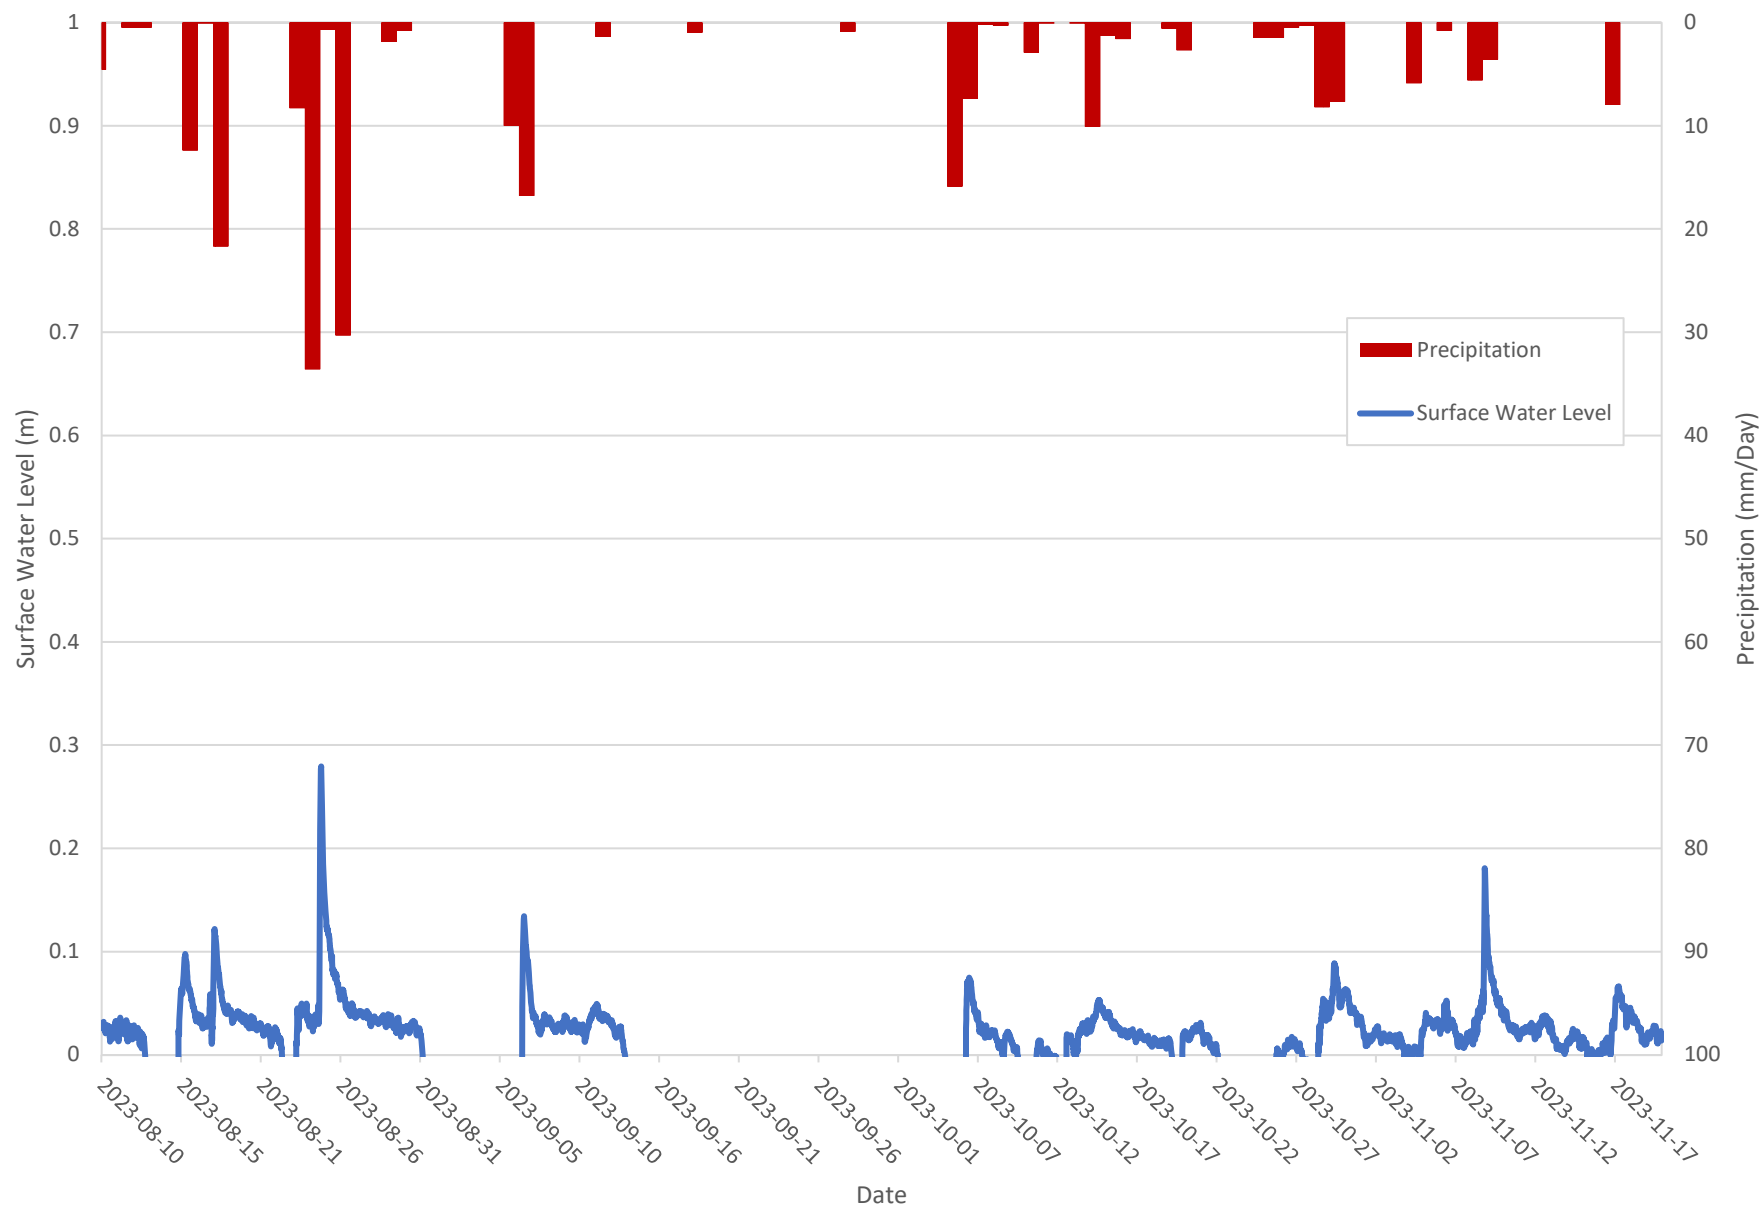
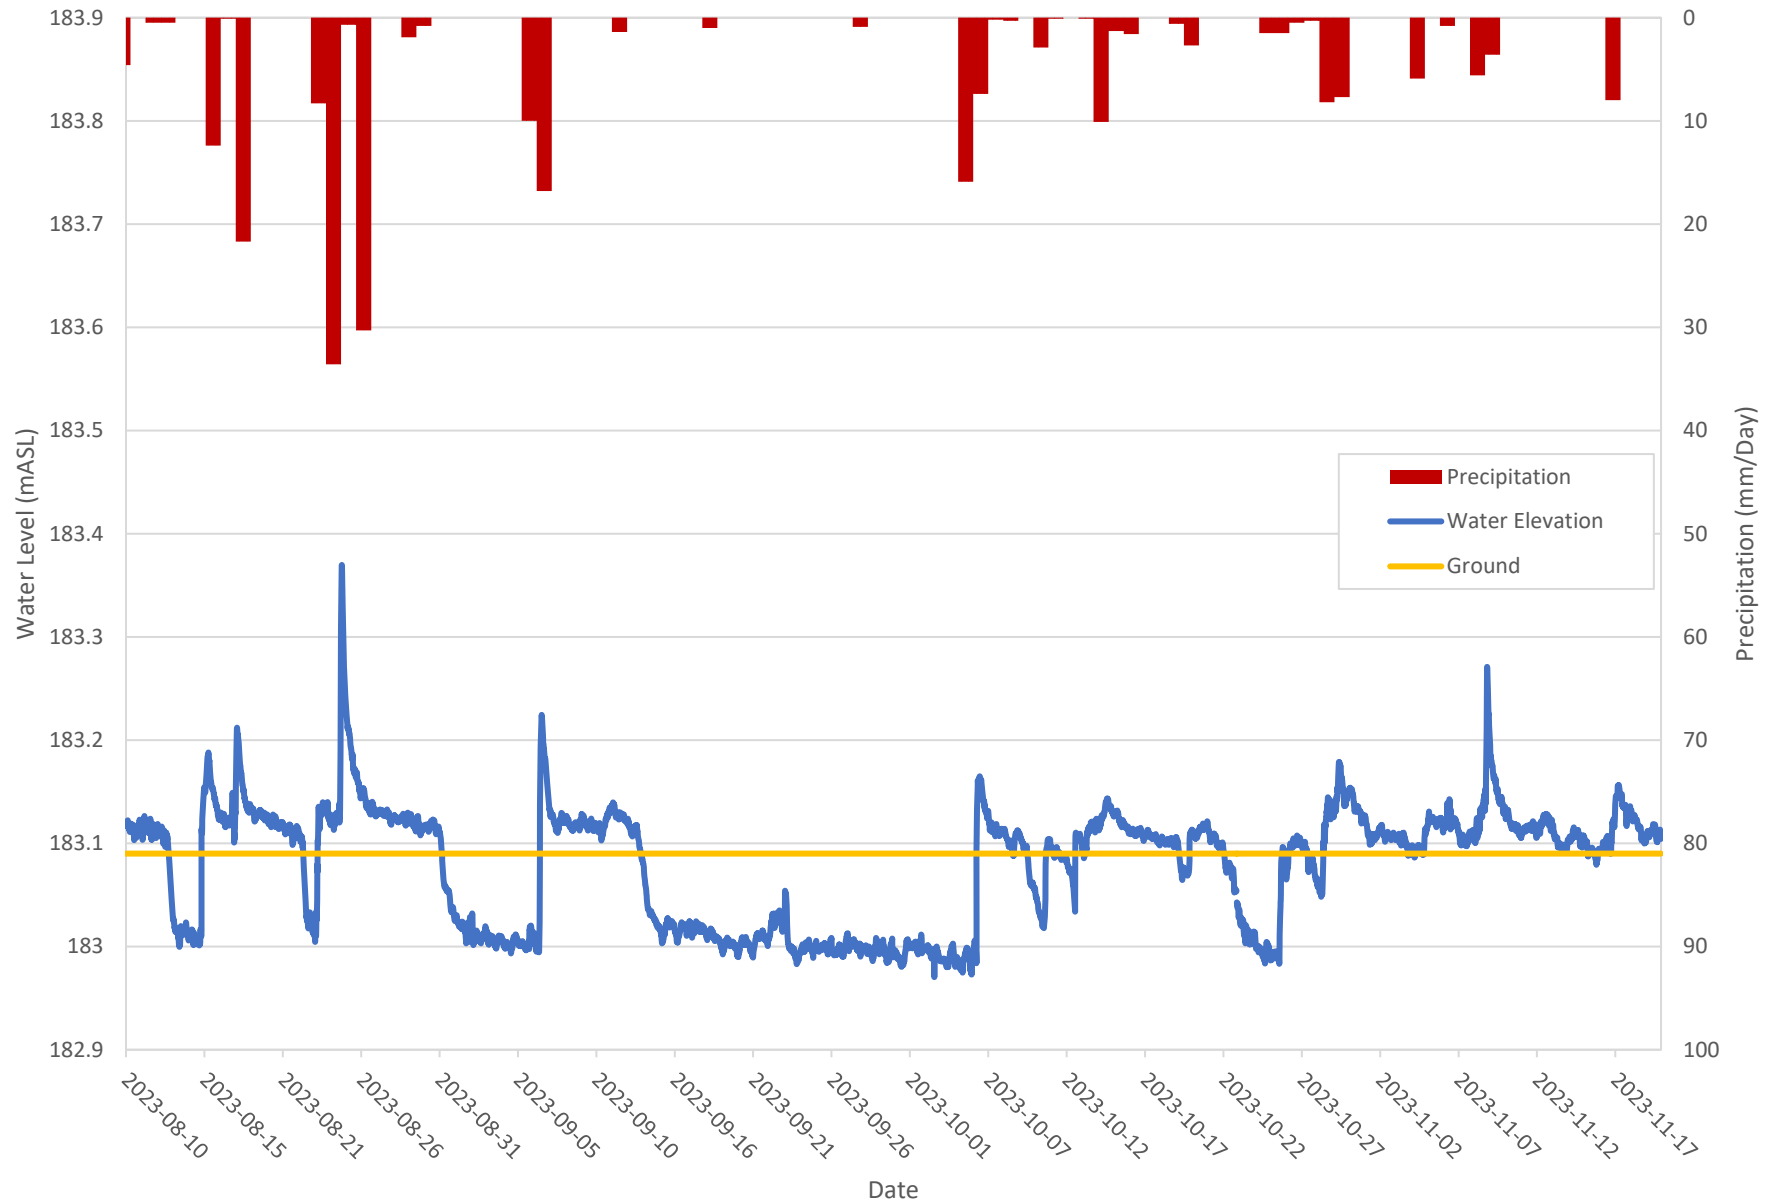
Tow Path Drain SG-101 Water Level and Precipitation August 10 to November 20, 2023

Tow Path Drain SG-101 Water Elevation and Precipitation August 10 to November 20, 2023

A series of four surface water staff gauges (SG-101, SG-102, SG-103 and SG-104) were installed on-site along Tow Path Drain in August 2023 (Figure 2, see attachments and Appendix F) and equipped with water level datalogger pressure transducers recording at 15-minutes intervals. The surface water monitoring was completed in addition to the original Terms of Reference (Appendix A). Clayey soils were observed beneath Tow Path Drain during the installation of the gauges via hand-augering completed to between 0.7-0.8 metres below ground surface. During the monitoring period (i.e. mid-August to mid-November 2023) August monthly precipitation was well-above average, while September, October and November monthly precipitation were well-below average (Table 1, see attachments). Water level monitoring of Tow Path Drain indicated surface water is only present intermittently as shown by dry conditions following precipitation events (Appendix F). Nearby groundwater levels were below ground surface during this monitoring period (BH21-13 and BH21-14) further confirming no groundwater discharge to surface water and an intermittent surface water classification consistent with other’s investigations. Water levels at the nearby wetlands were observed to rise following precipitation events (Appendix C). After precipitation events, the water levels at nearby wetlands responded one of two ways:

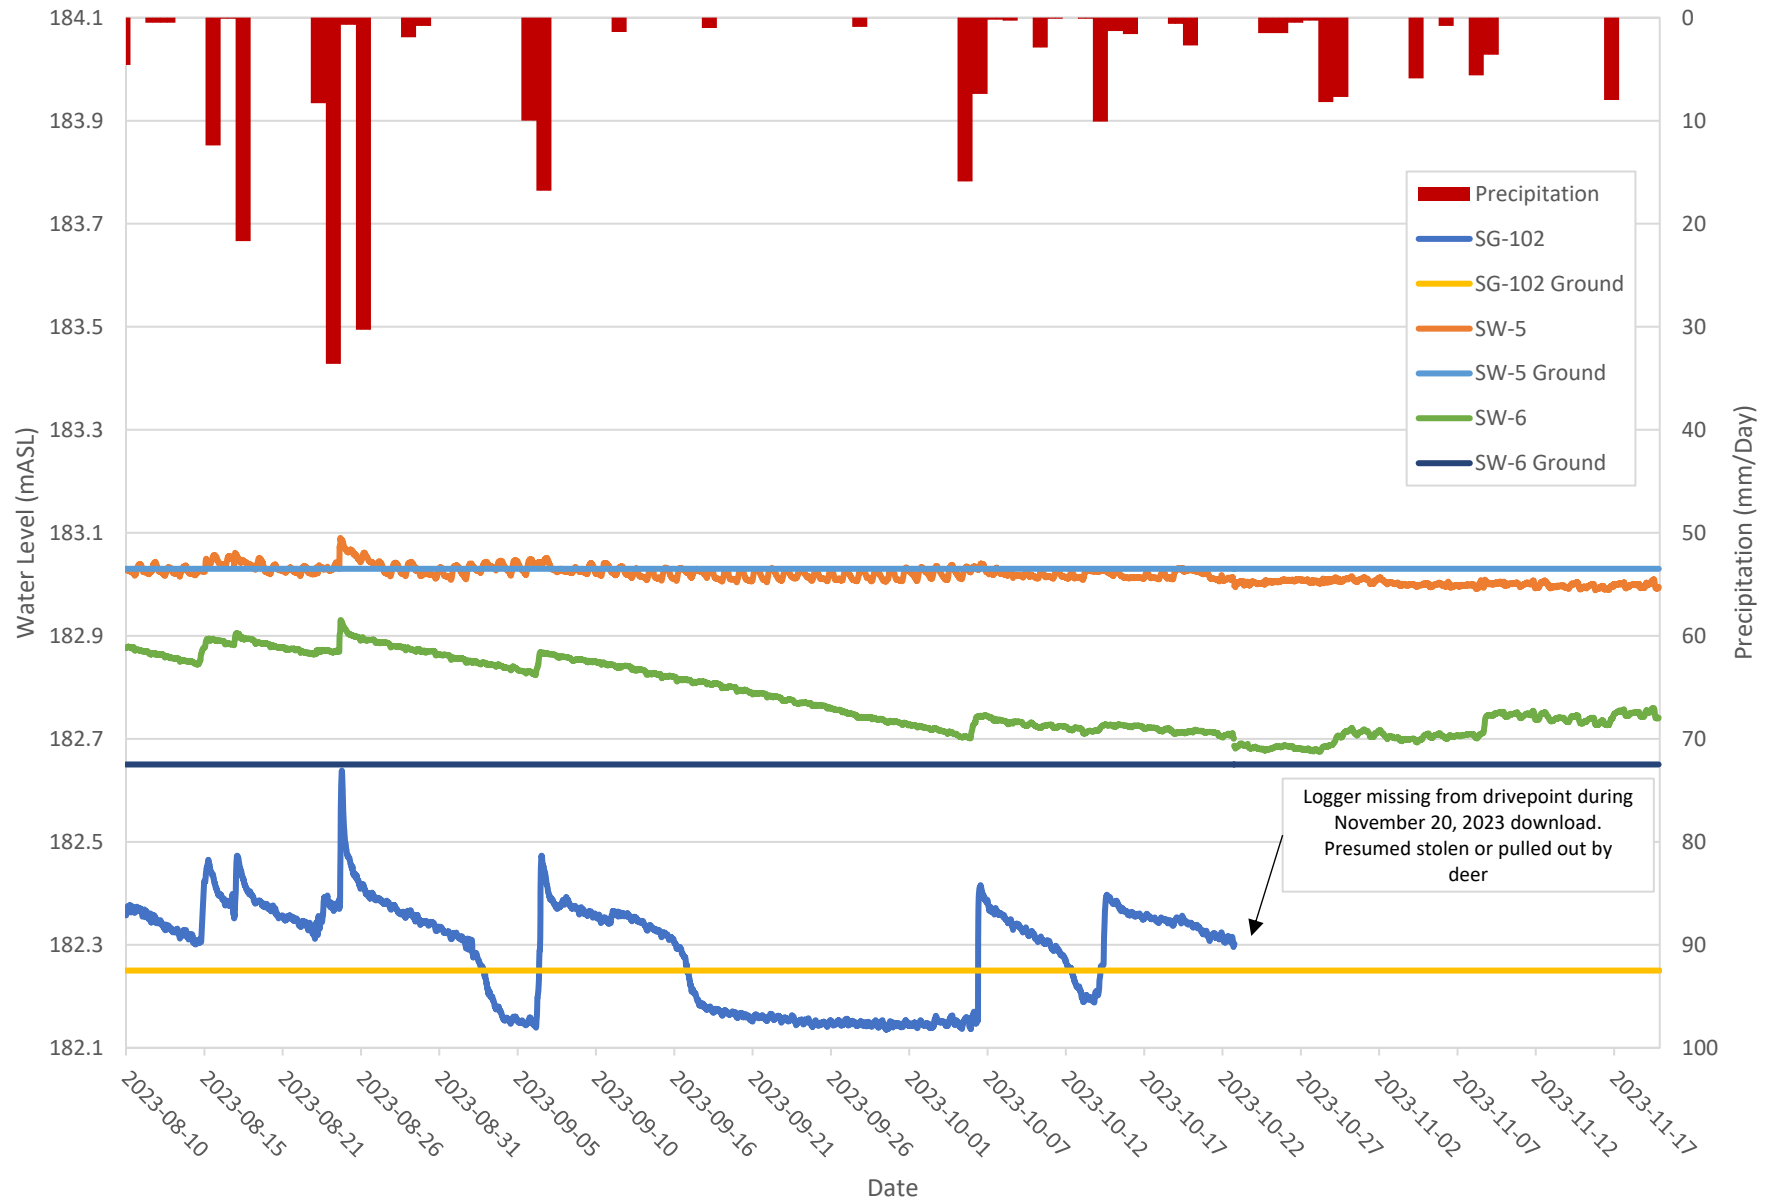
SG-102, SW-5 and SW-6 Water Elevation and Precipitation August 10 to November 20, 2023

Wetlands near the Tow Path Drain are primarily sustained by precipitation (Sections 3.6.2 and 4.2), not sustained by backflow retained in the Tow Path Drain, as shown in September 2023 when limited standing water was still present at wetland gauges (i.e. SW-3, SW-4, SW-5, SW-6, SW-8 and SW-9, Appendix E) while dry conditions were observed downgradient at SG-102 and SG-103 (Appendix F).

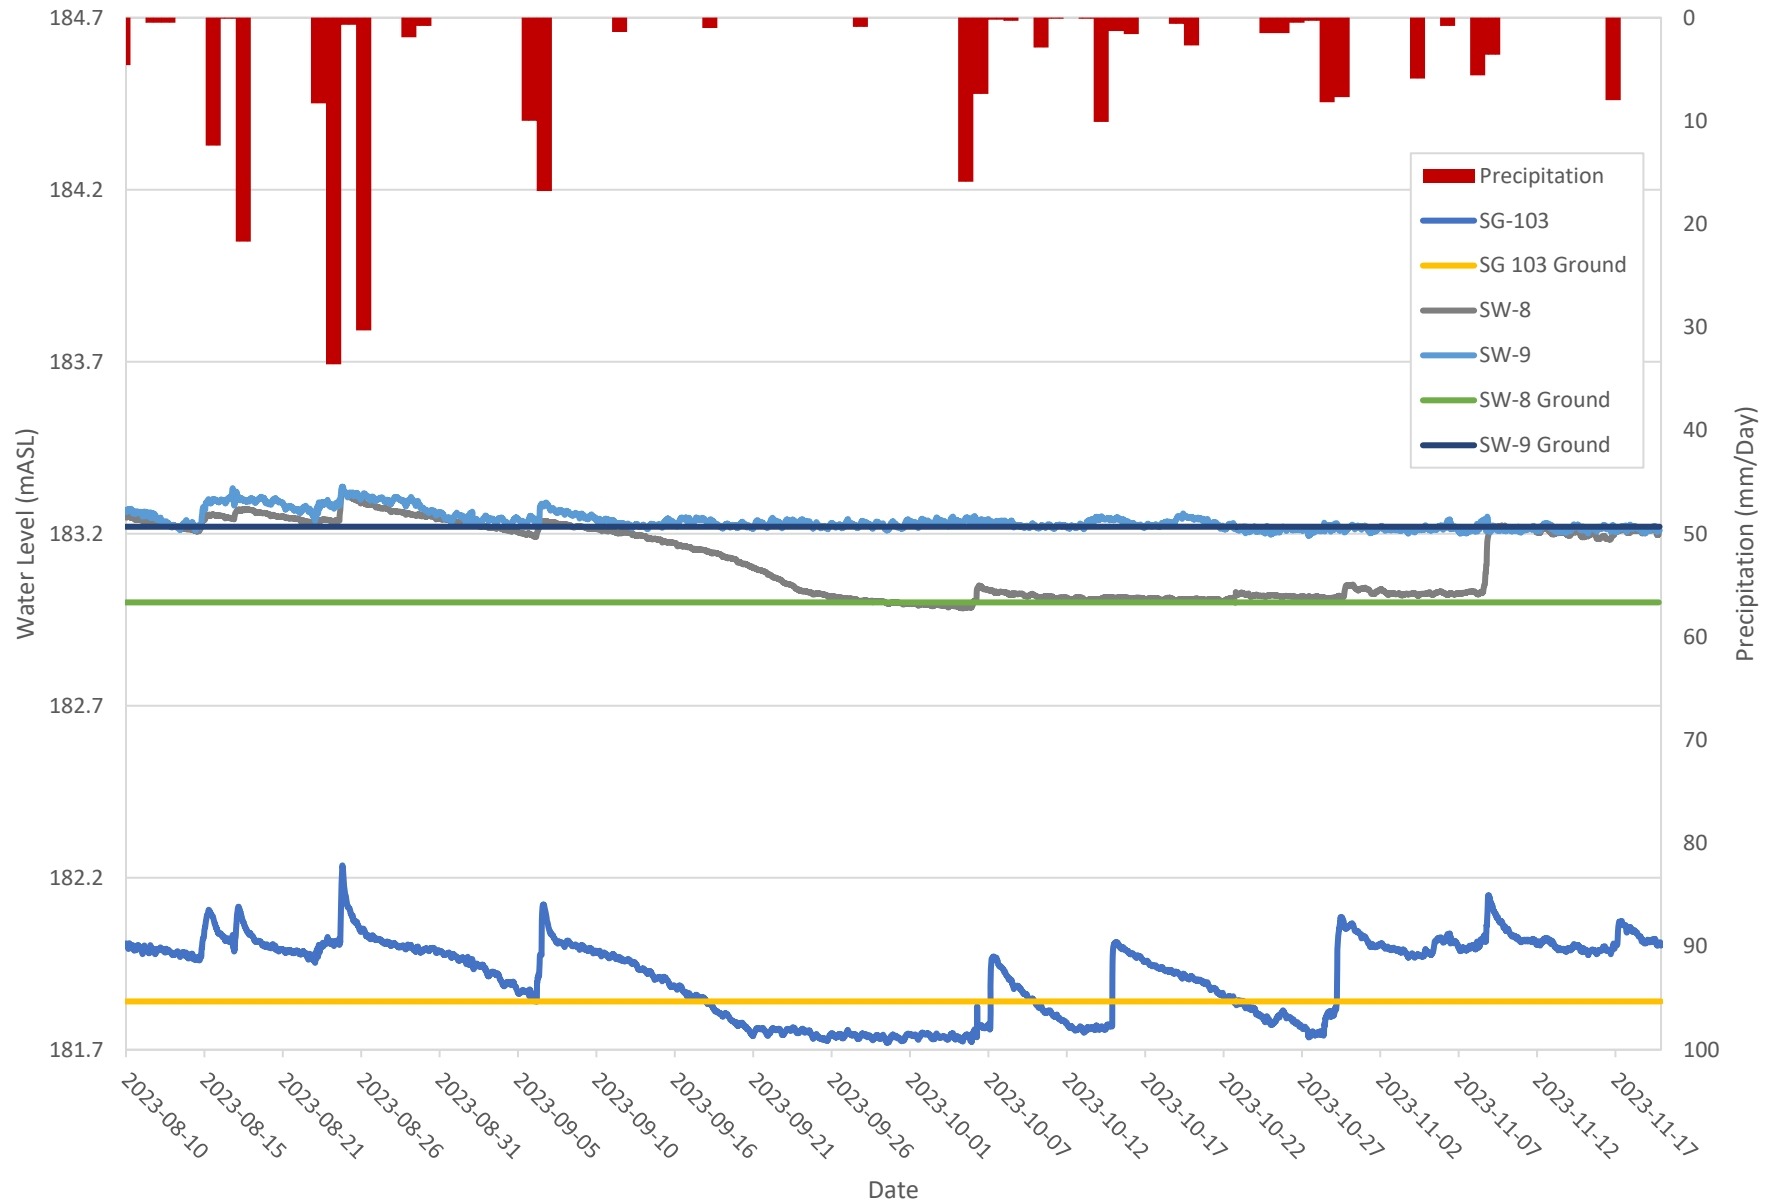
SG-103, SW-8 and SW-9 Water Elevation and Precipitation August 10 to November 20, 2023
