Phase Two Environmental Site Assessment

13030 Lundy's Lane, Thorold, Ontario

GTR-21019405-B0

July 14, 2022

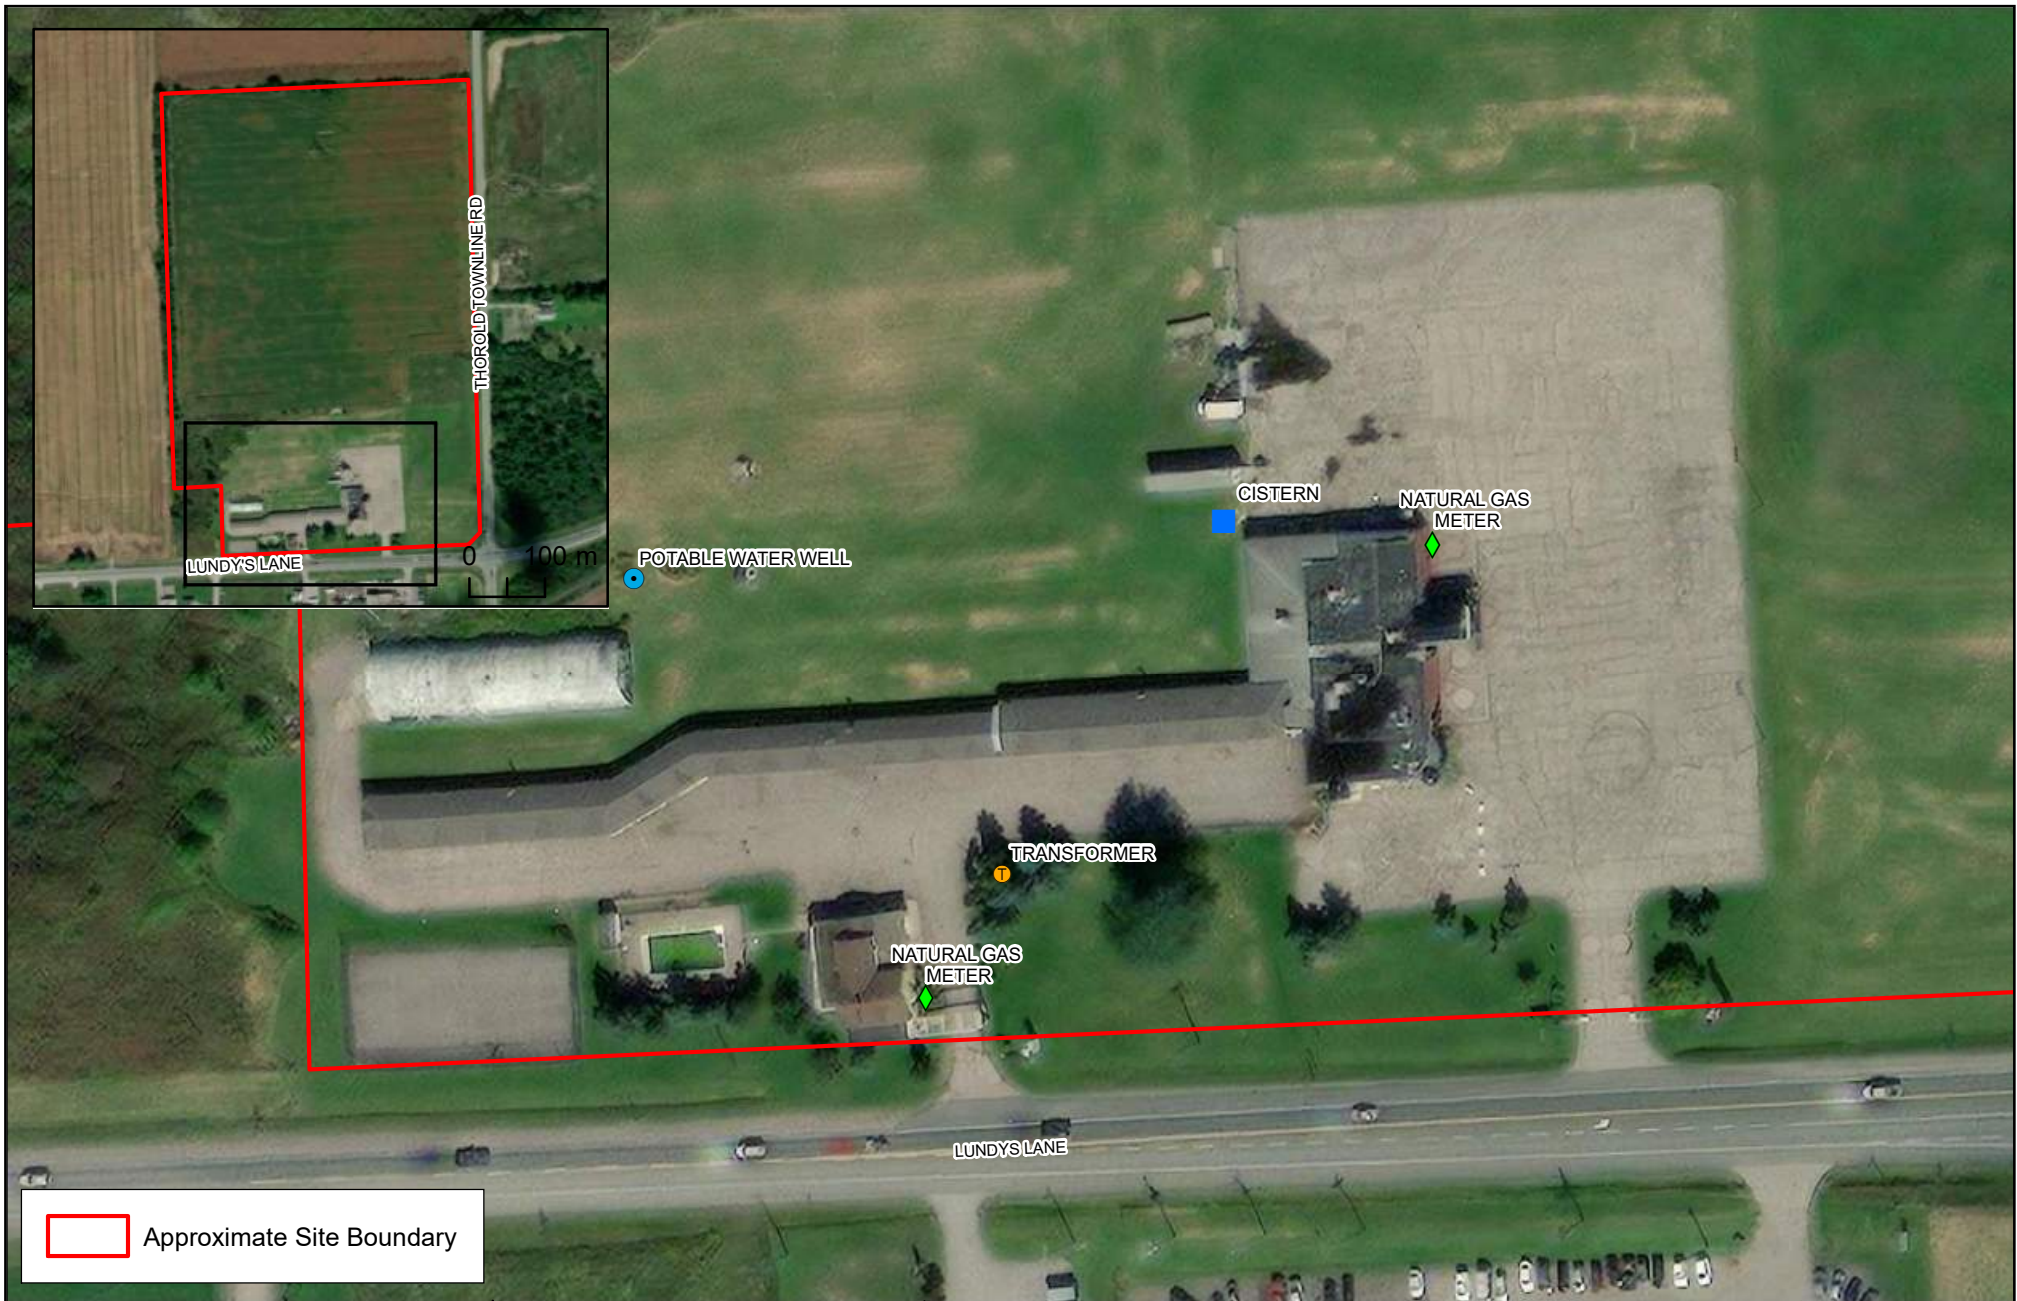
PROJECT No.: GTR-21019405-A0	OWN: AC
SCALE: AS NOTED	CHKD: LE
DATE: DECEMBER 2021	FIG. No.: 2

TITLE AND LOCATION:
**PHASE ONE STUDY AREA, LAND USE PLAN, AND
 POTENTIALLY CONTAMINATING ACTIVITIES (PCAs)**
 Phase Two Environmental Site Assessment
 13030 Lundy's Lane
 Thorold, Ontario

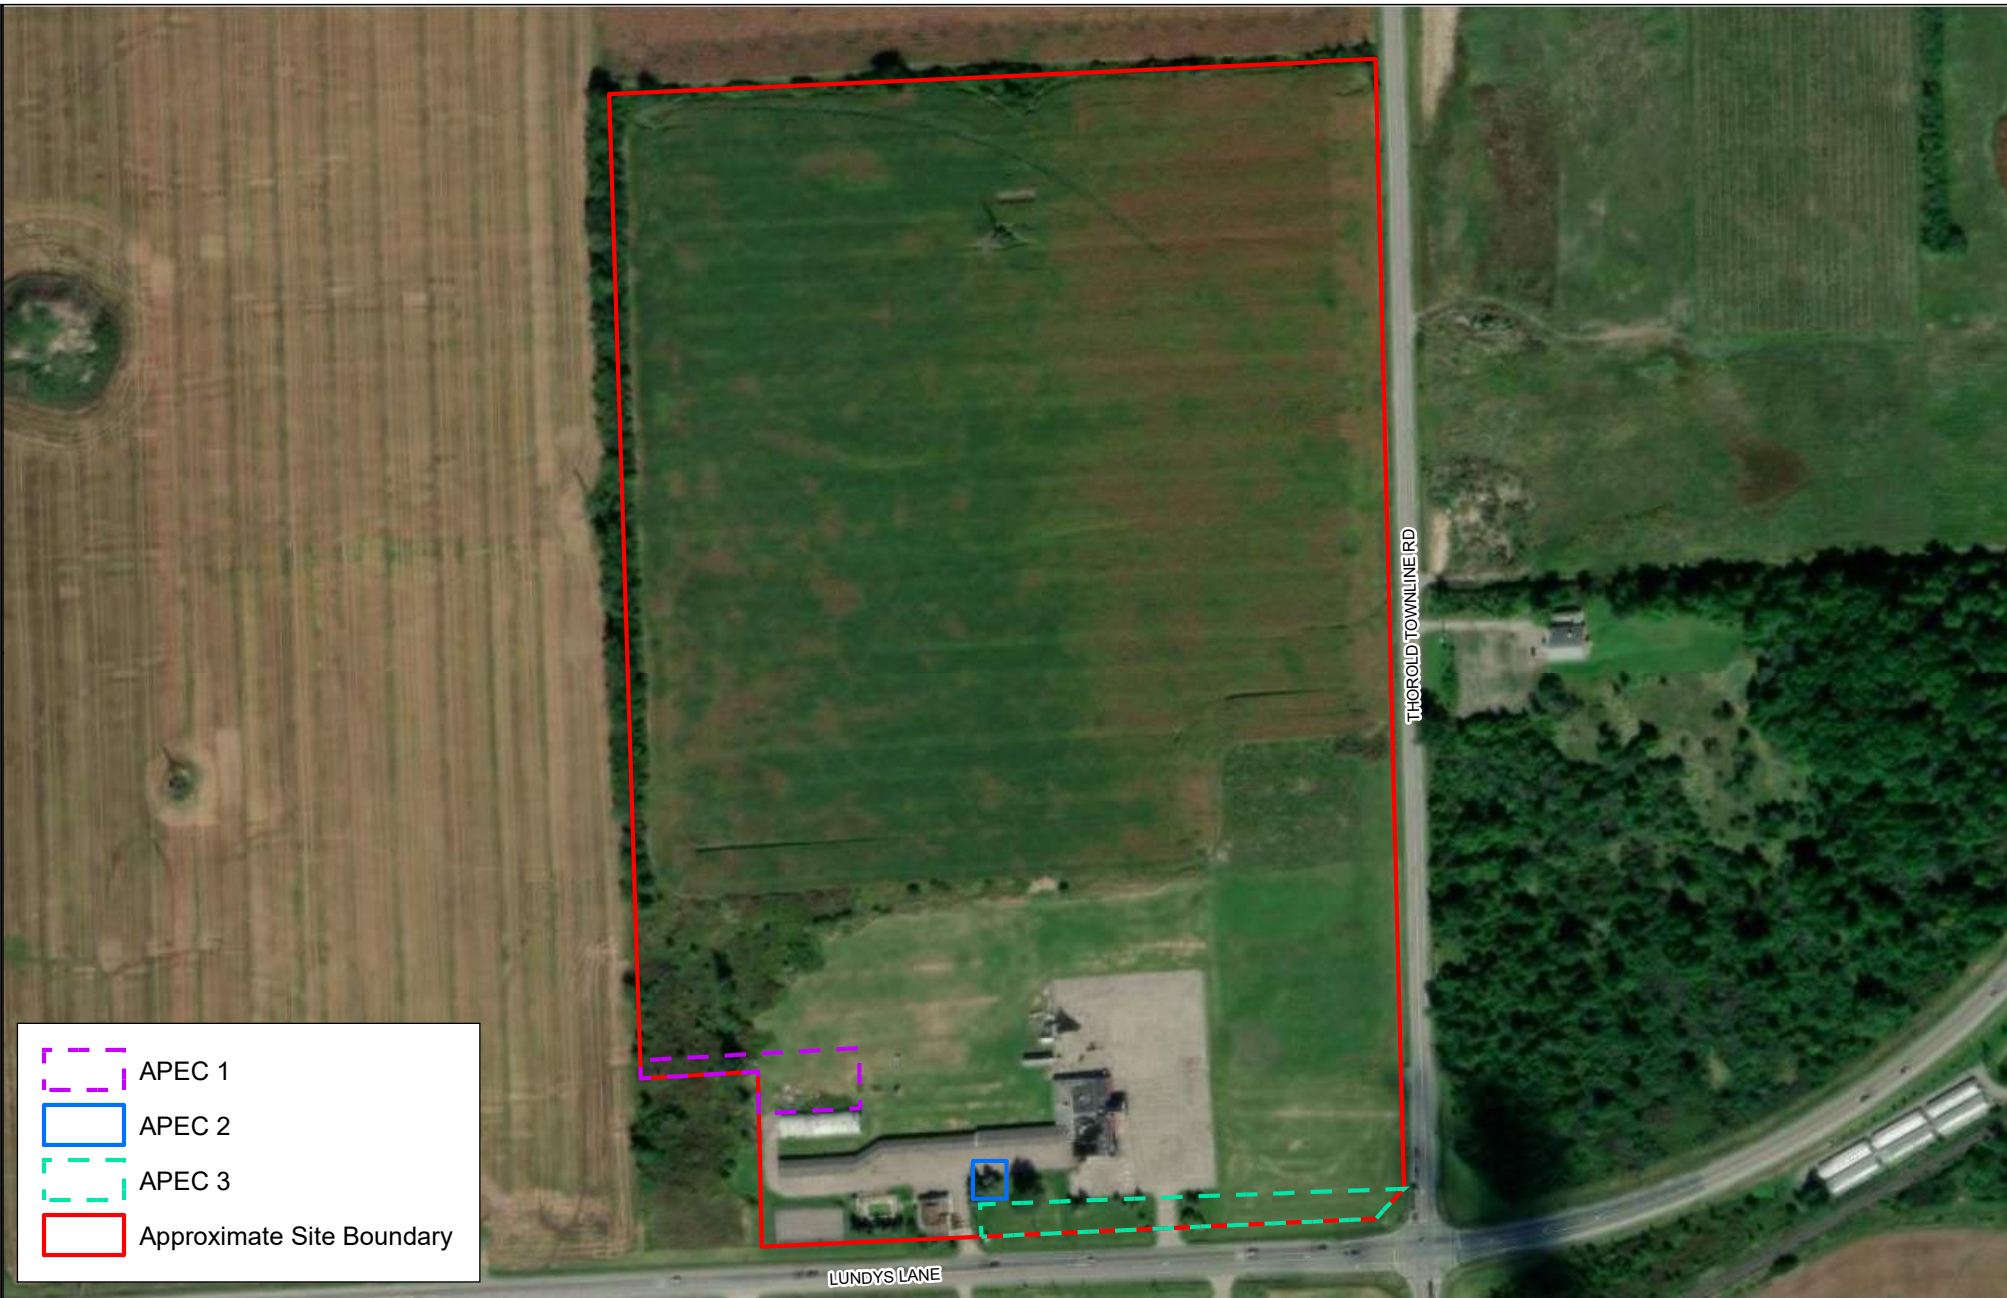
PROJECT No.: GTR-21019405-A0	OWN: AC
SCALE: AS NOTED	CHKD: LE
DATE: DECEMBER 2021	FIG. No.: 4

TITLE AND LOCATION:
 AREAS OF POTENTIAL ENVIRONMENTAL CONCERN (APECs)
 Phase Two Environmental Site Assessment
 13030 Lundy's Lane
 Thorold, Ontario

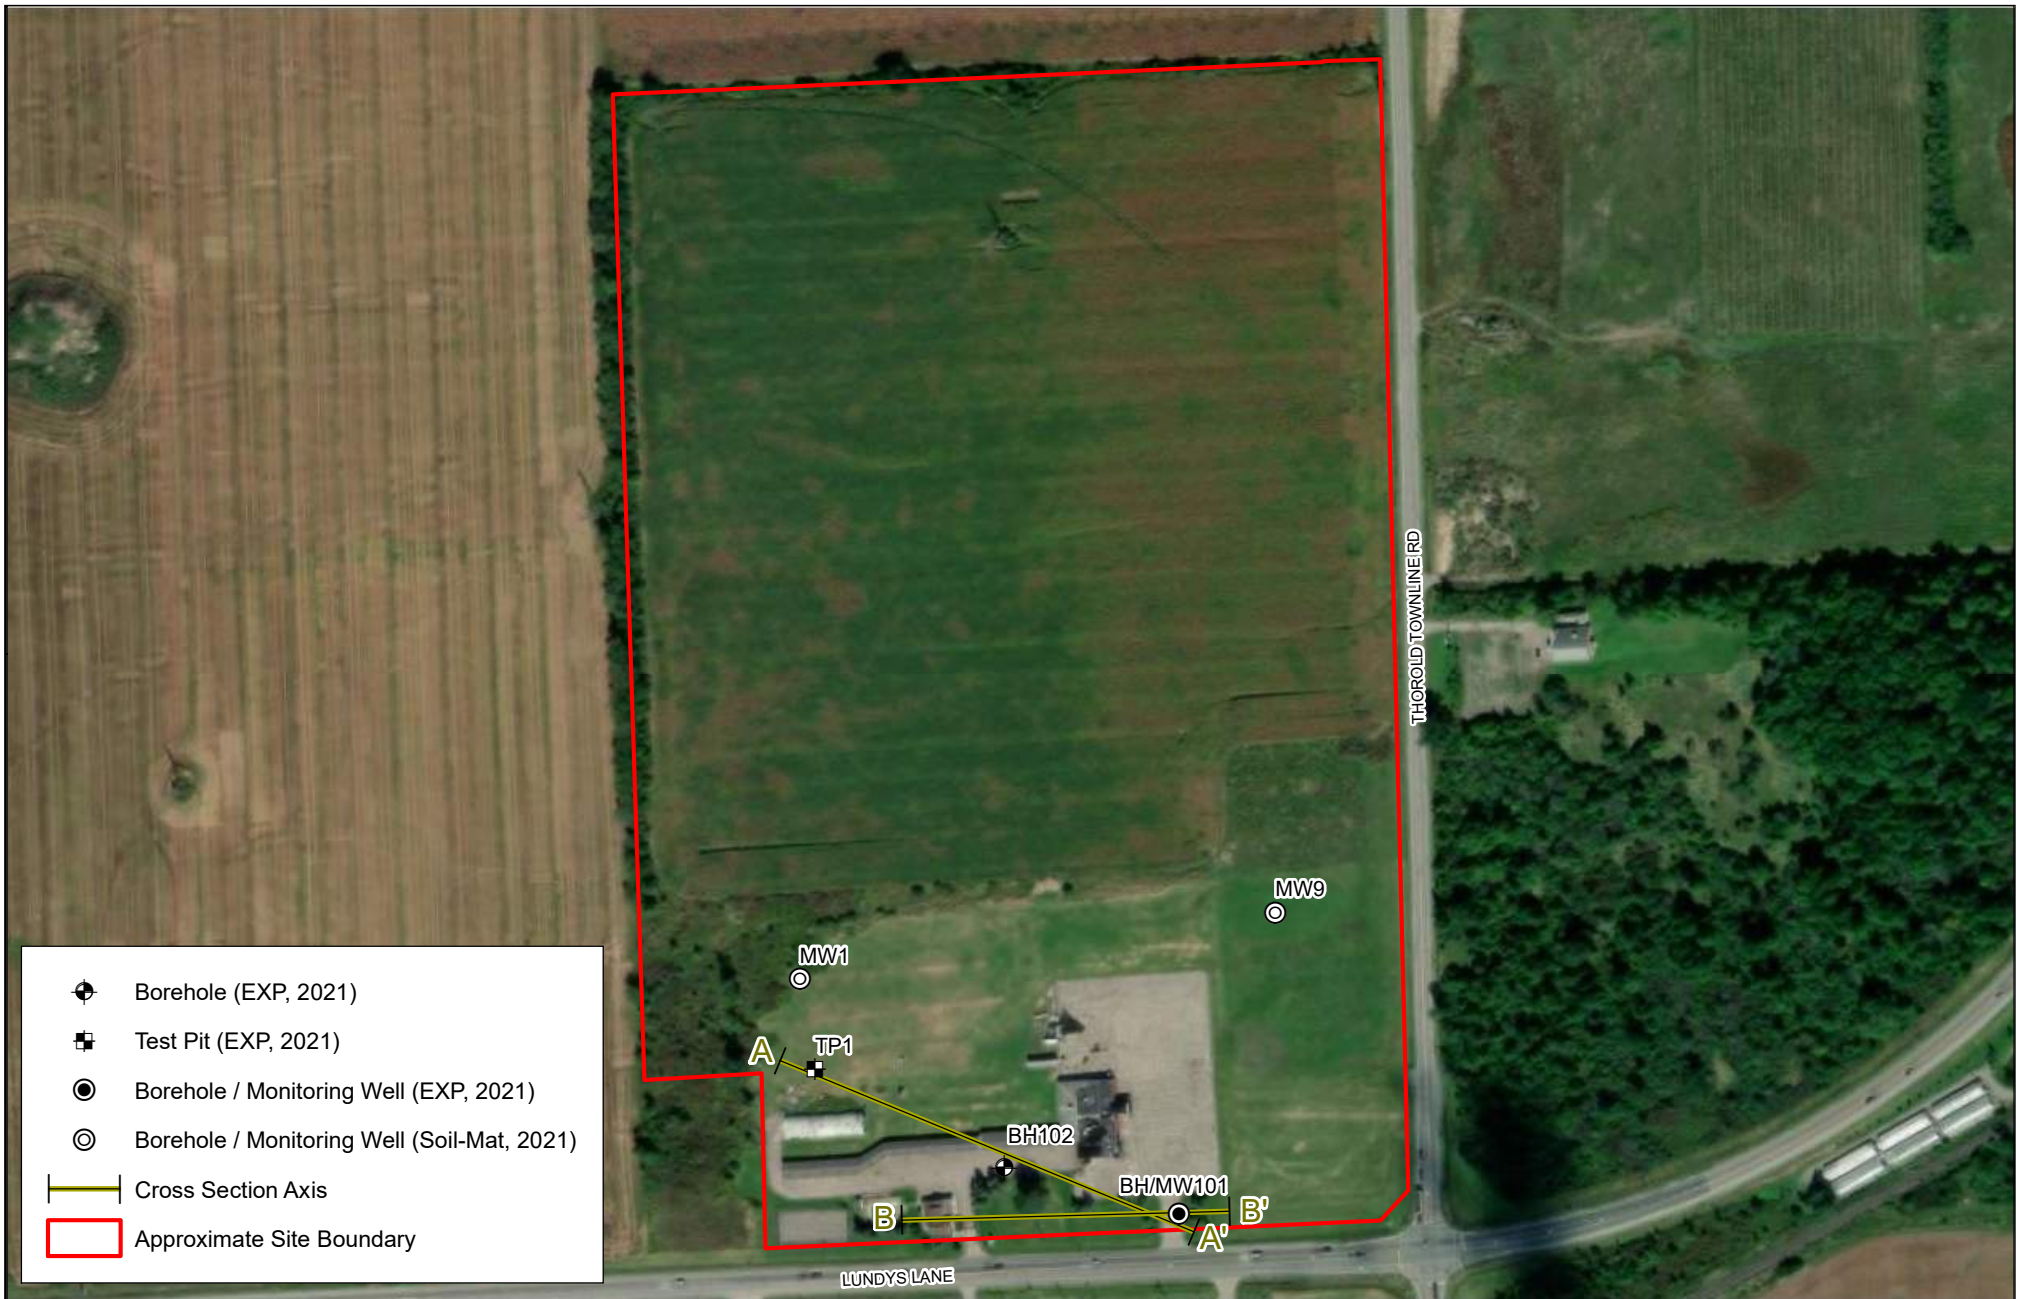
PROJECT No.:	GTR-21019405-A0	OWN:	AC
SCALE:	AS NOTED	CHKD:	LE
DATE:	DECEMBER 2021	FIG. No.:	5A

-   Borehole (EXP, 2021)
-   Test Pit (EXP, 2021)
-   Borehole / Monitoring Well (EXP, 2021)
-   Borehole / Monitoring Well (Soil-Mat, 2021)
-   Cross Section Axis
-   Approximate Site Boundary

TITLE AND LOCATION:
**BOREHOLE / MONITORING WELL
 LOCATION PLAN**
 Phase Two Environmental Site Assessment
 13030 Lundy's Lane
 Thorold, Ontario

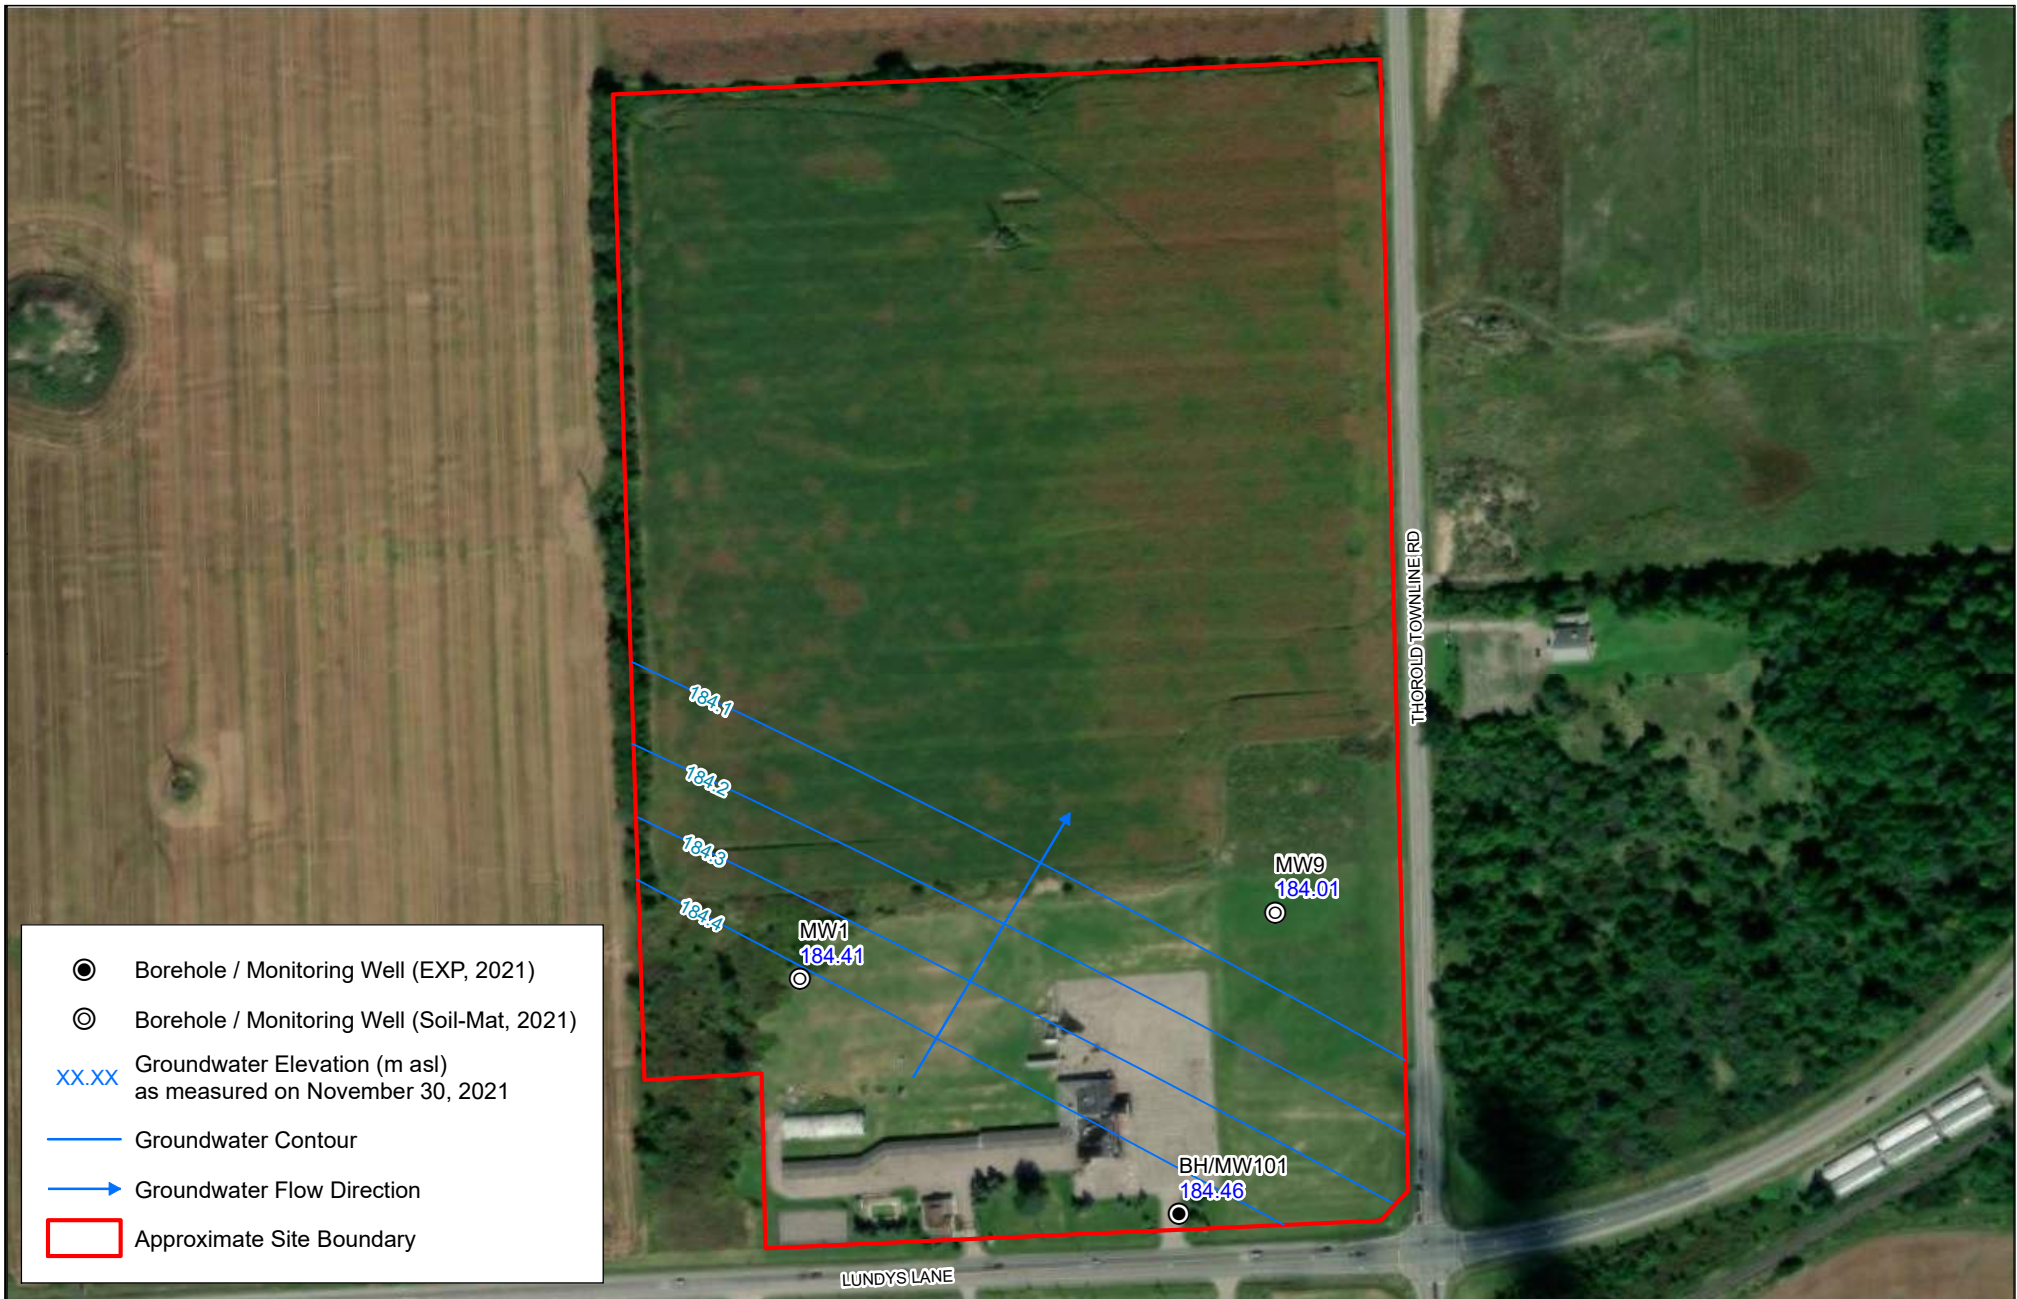
PROJECT No:	GTR-21019405-A0	OWN:	AC
SCALE:	AS NOTED	CHKD:	LE
DATE:	DECEMBER 2021	FIG. No.:	6

- Borehole / Monitoring Well (EXP, 2021)
- Borehole / Monitoring Well (Soil-Mat, 2021)
- XX.XX Groundwater Elevation (m asl)
as measured on November 30, 2021
- Groundwater Contour
- Groundwater Flow Direction
- Approximate Site Boundary

TITLE AND LOCATION:
GROUNDWATER CONTOUR PLAN
 Phase Two Environmental Site Assessment
 13030 Lundy's Lane
 Thorold, Ontario

- The horizontal hydraulic gradient on-Site ranged from 0.005 m/m (between BH/MW101 and MW-9) and 0.785 m/m (between BH/MW101 and MW-1).
- Soil samples were submitted for the analysis of Petroleum Hydrocarbons (PHCs) including Benzene, Toluene, Ethylbenzene, and Xylenes (BTEX), Polychlorinated Biphenyls (PCBs), Organochlorinated Pesticides (OCs), and pH and 75-micron sieve.
- All parameters were either non-detected or detected below their applicable MECP (2011) Table 2 Site Condition Standards (SCS).
- Groundwater samples were submitted for the analysis of PHCs, BTEX, and Metals.
- All parameters were either non-detected or detected below their applicable MECP (2011) Table 2 SCS.
- No evidence of free product (i.e., visible film or sheen), or odor was observed during soil sampling, groundwater purging, or groundwater sampling activities.

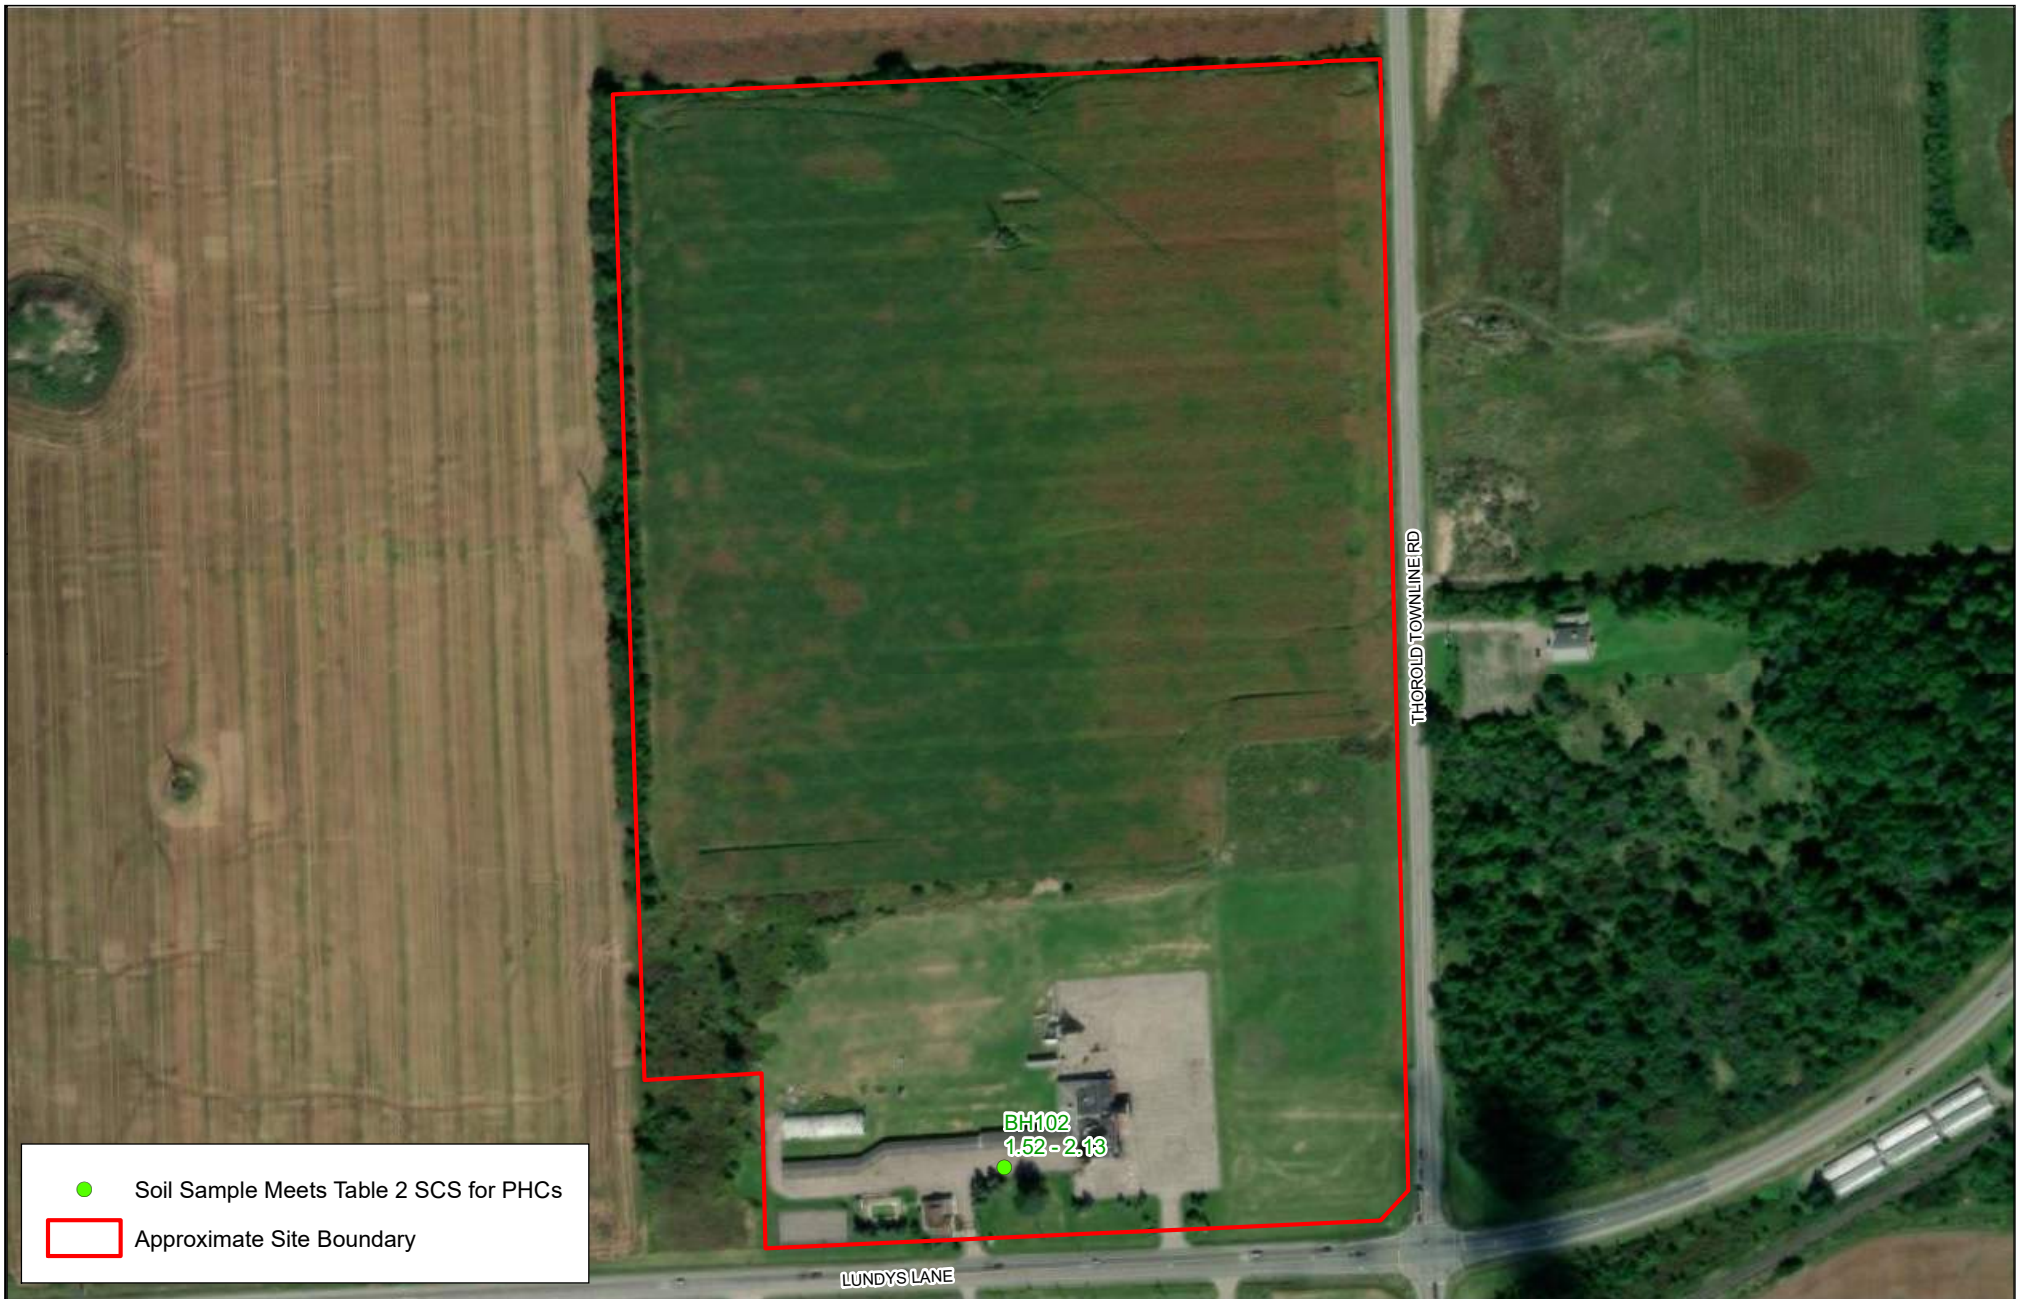
<small>PROJECT No.:</small> GTR-21019405-A0	<small>OWN:</small> AC
<small>SCALE:</small> AS NOTED	<small>CHKD:</small> LE
<small>DATE:</small> DECEMBER 2021	<small>FIG. No.:</small> 7

- Soil Sample Meets Table 2 SCS for PHCs
- Approximate Site Boundary

TITLE AND LOCATION:
 SOIL ANALYTICAL RESULTS -
 PETROLEUM HYDROCARBONS (PHCs)
 INCLUDING BTEX
 Phase Two Environmental Site Assessment
 13030 Lundy's Lane
 Thorold, Ontario

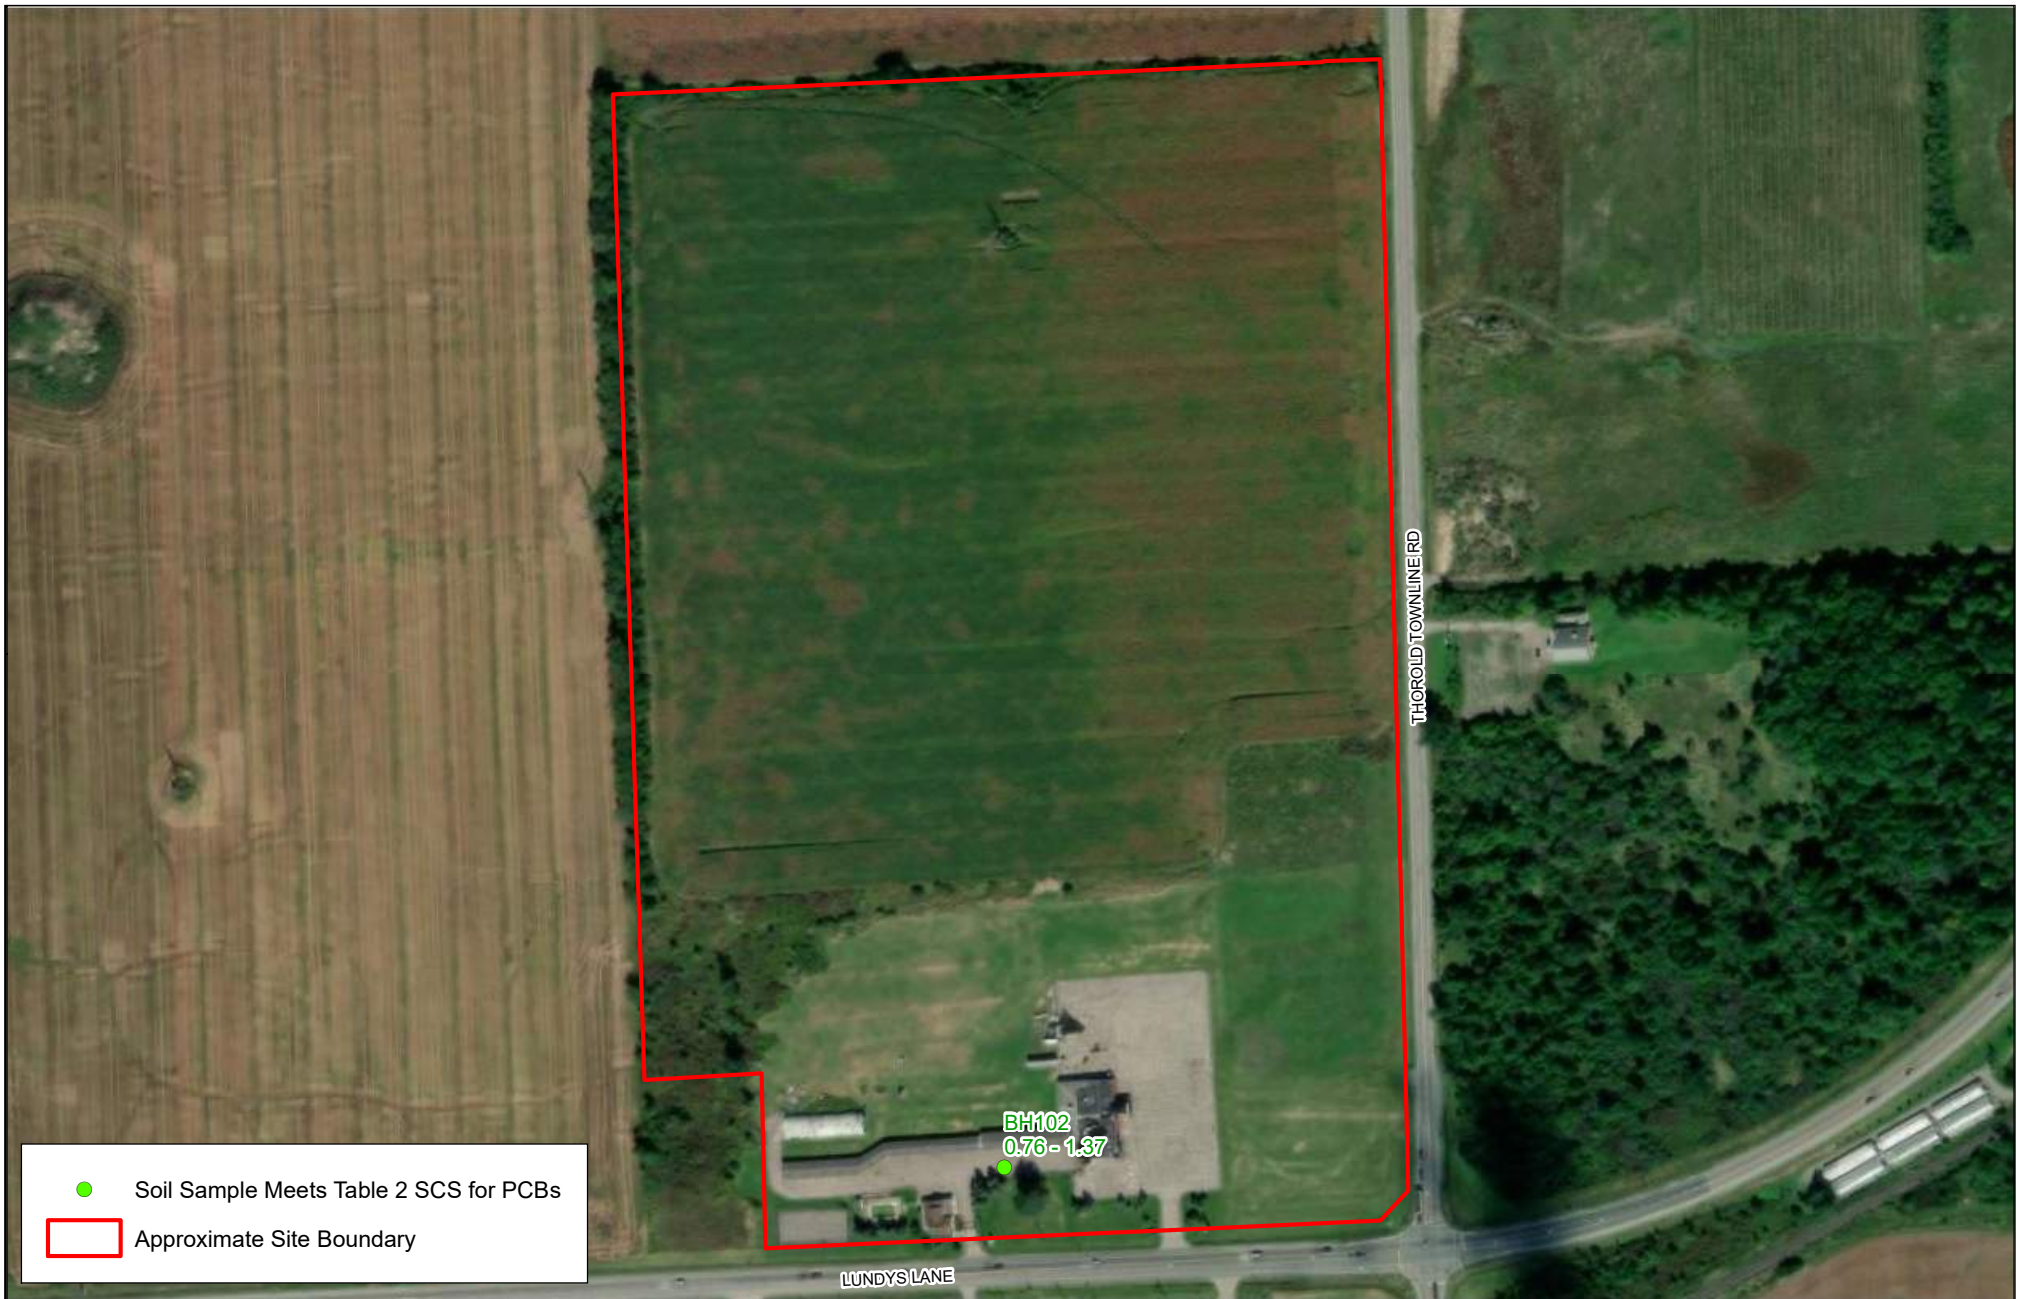
PROJECT No.:	GTR-21019405-A0	OWN:	AC
SCALE:	AS NOTED	CHKD:	LE
DATE:	DECEMBER 2021	FIG. No.:	8

- Soil Sample Meets Table 2 SCS for PCBs
- Approximate Site Boundary

TITLE AND LOCATION:
 SOIL ANALYTICAL RESULTS -
 POLYCHLORINATED BIPHENYLS (PCBs)
 Phase Two Environmental Site Assessment
 13030 Lundy's Lane
 Thorold, Ontario

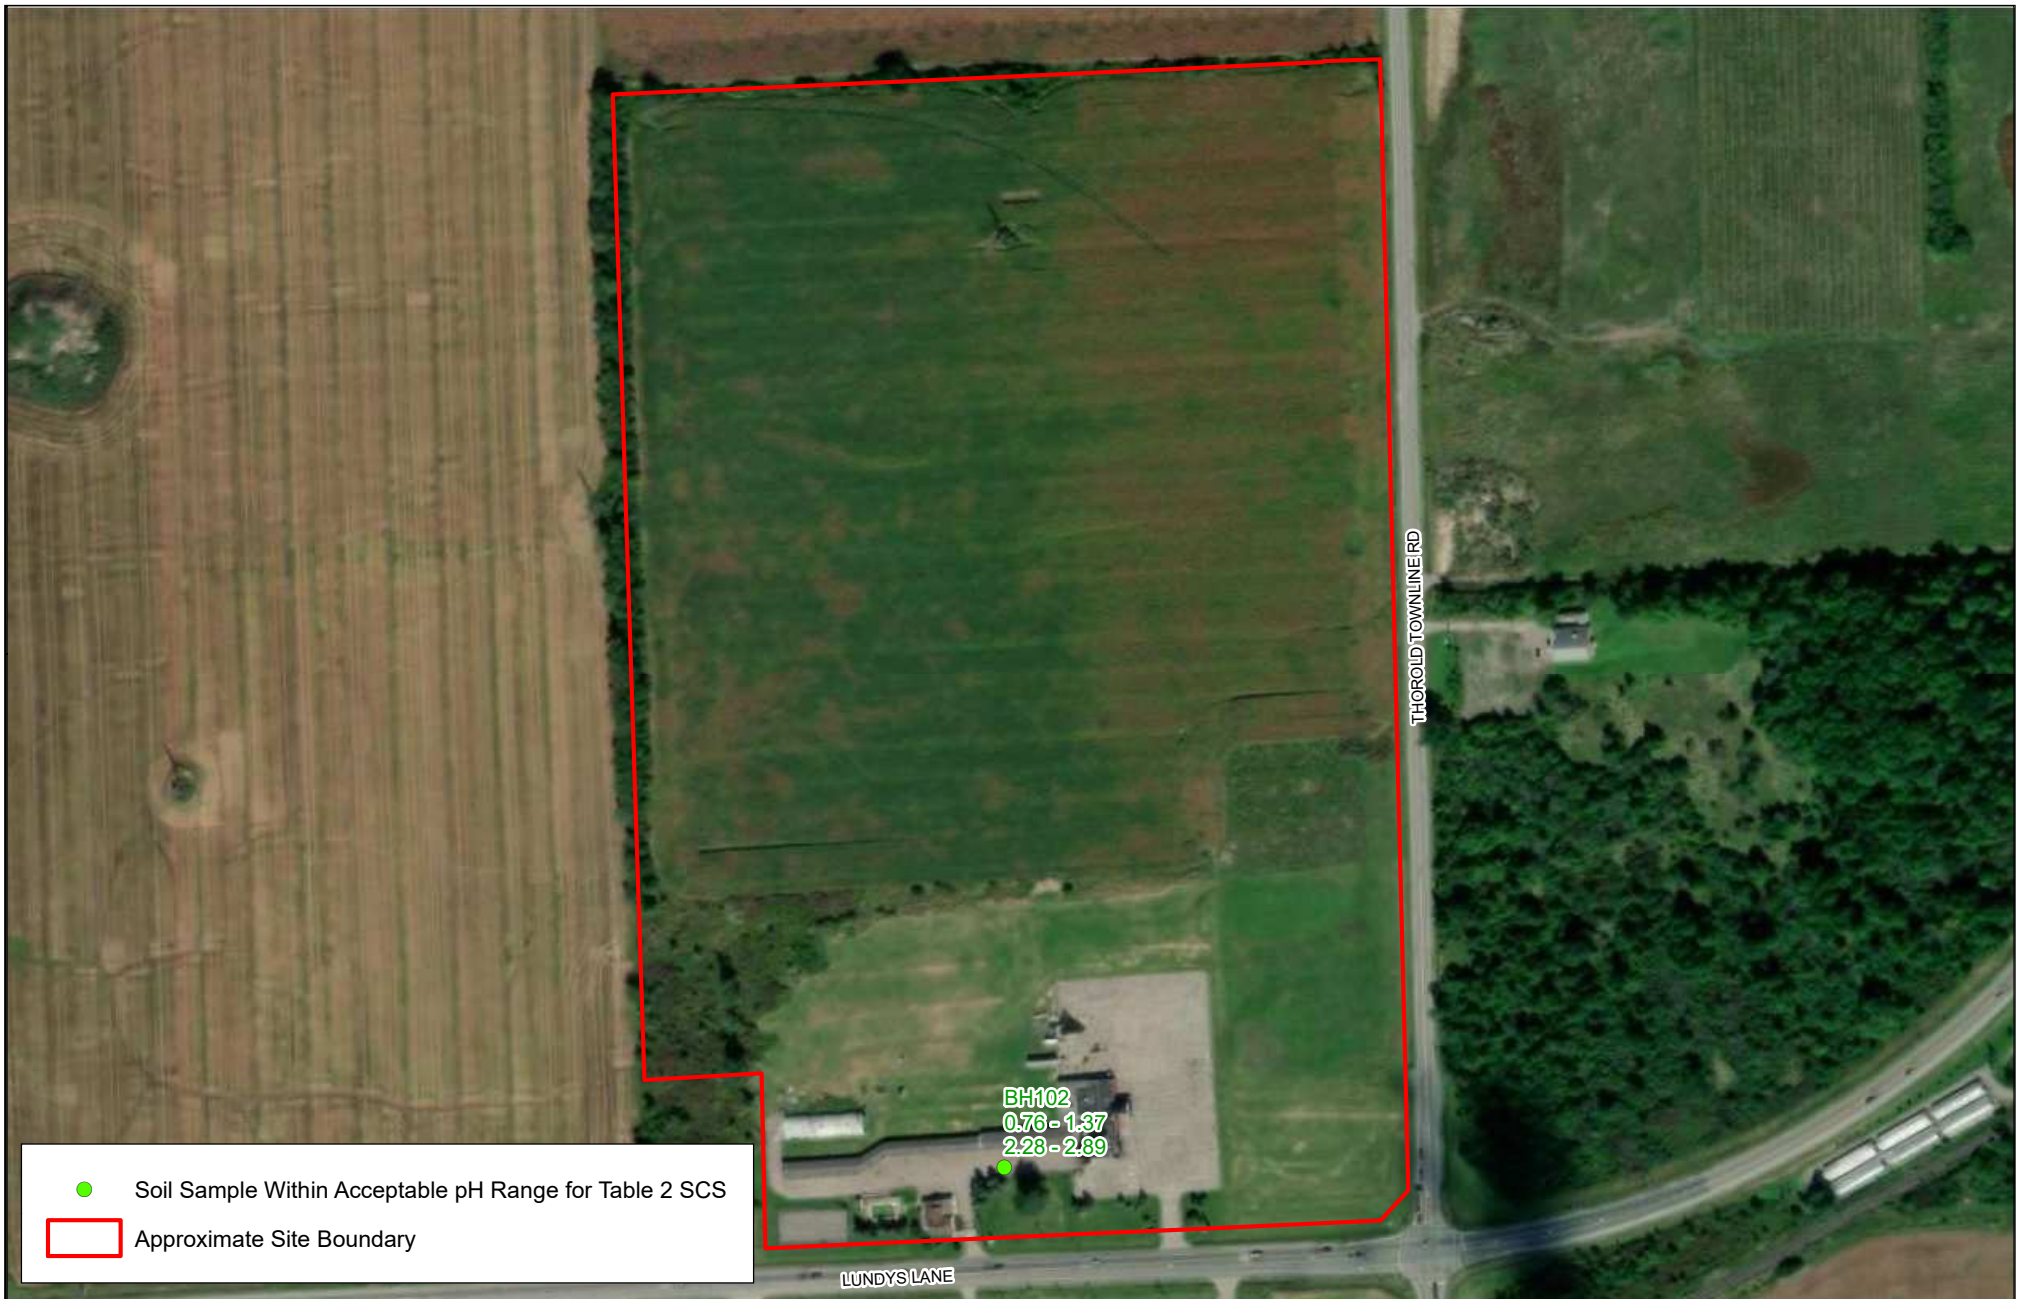
PROJECT No:	GTR-21019405-A0	OWN:	AC
SCALE:	AS NOTED	CHKD:	LE
DATE:	DECEMBER 2021	FIG. No.:	9

● Soil Sample Within Acceptable pH Range for Table 2 SCS
 Approximate Site Boundary

SOIL ANALYTICAL RESULTS - pH
 Phase Two Environmental Site Assessment
 13030 Lundy's Lane
 Thorold, Ontario

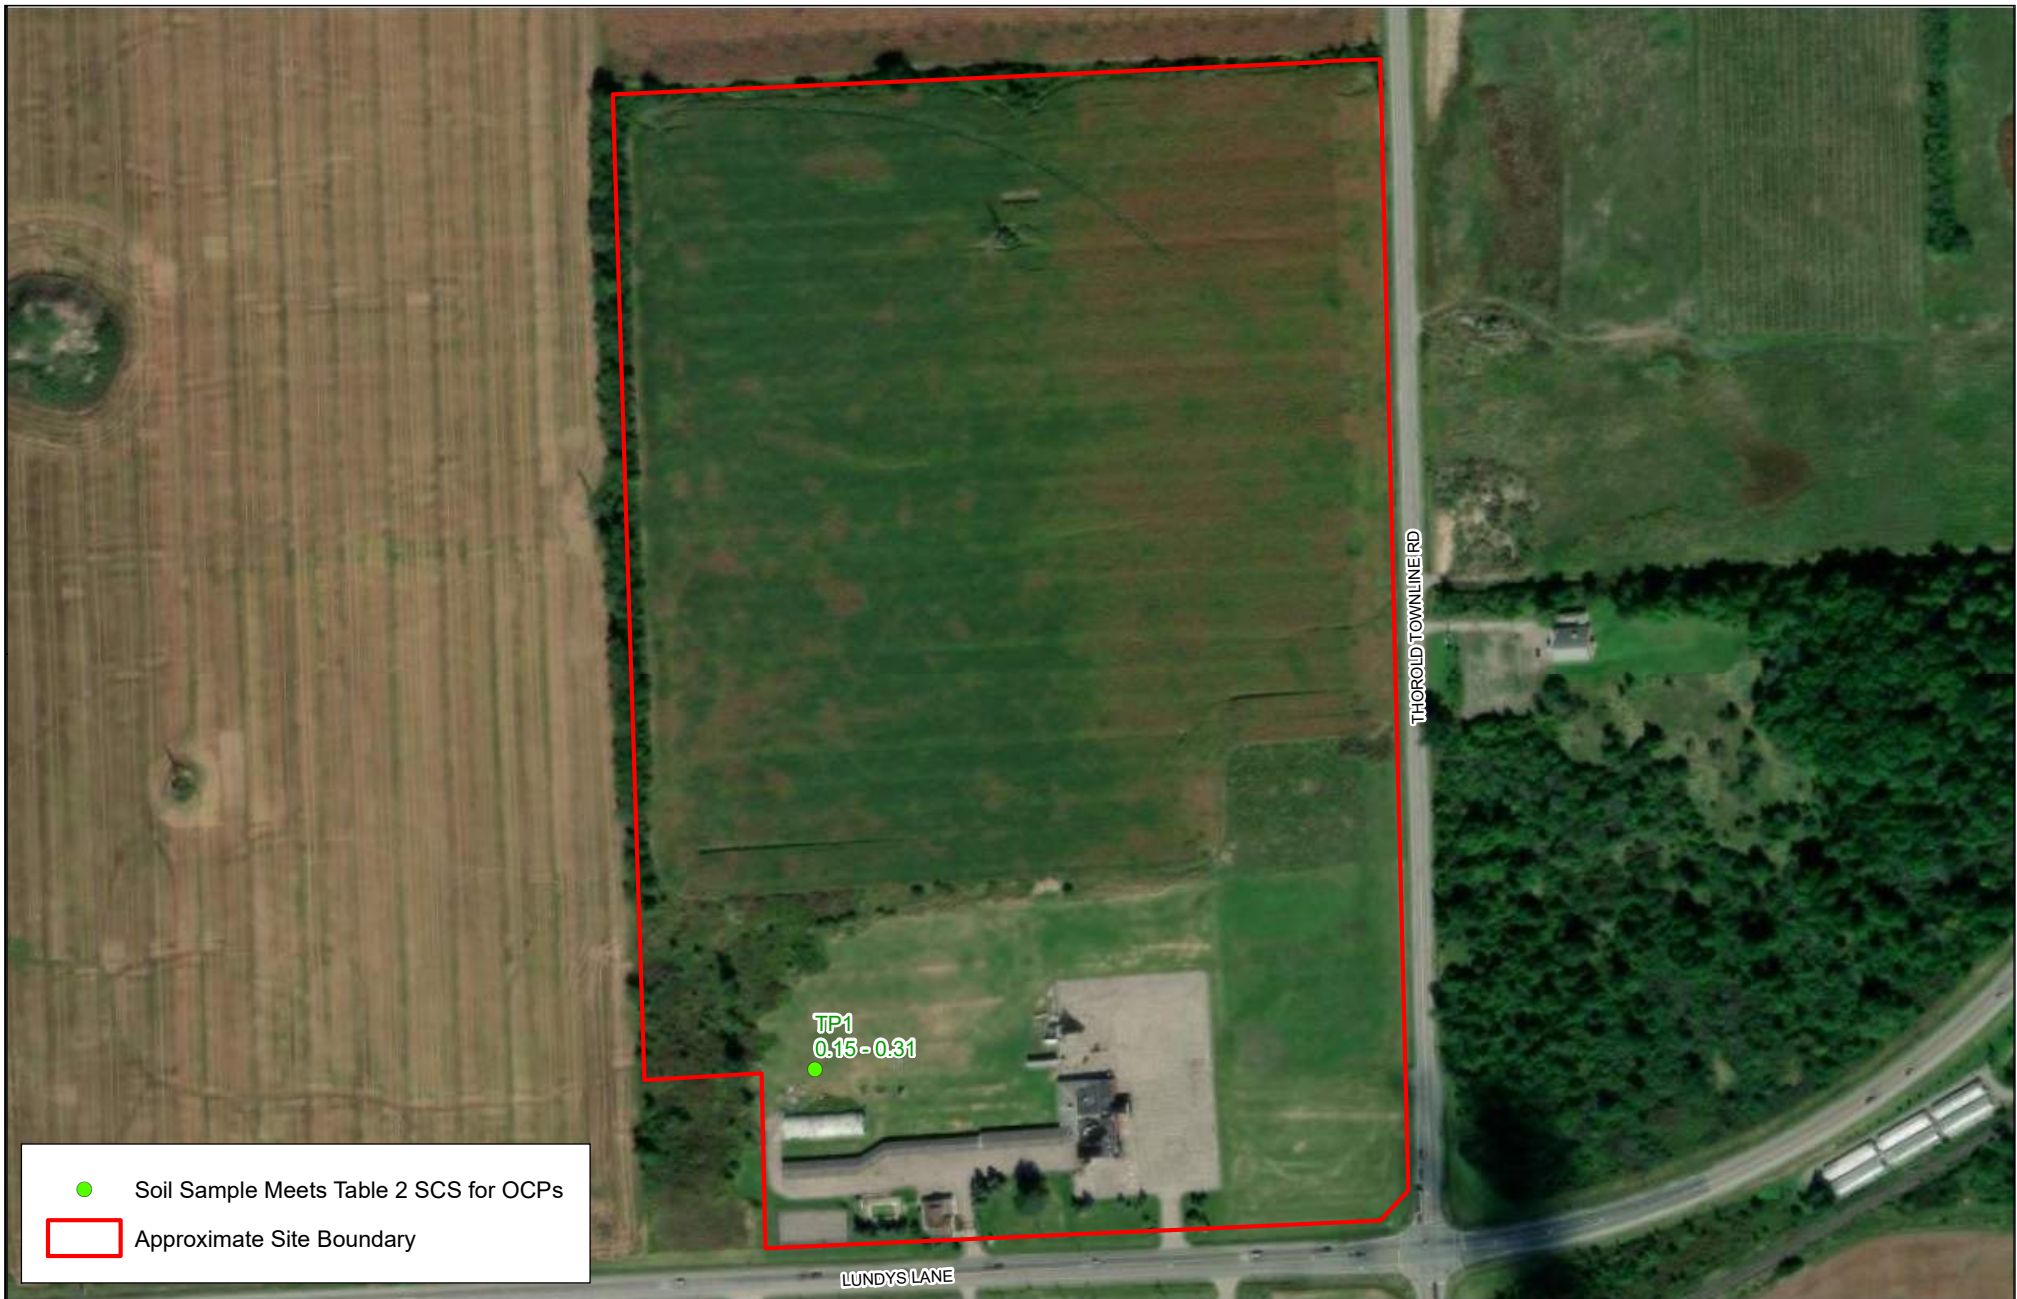
PROJECT No.:	GTR-21019405-A0	OWN:	AC
SCALE:	AS NOTED	CHKD:	LE
DATE:	DECEMBER 2021	FIG. No.:	10

● Soil Sample Meets Table 2 SCS for OCPs
 Approximate Site Boundary

**SOIL ANALYTICAL RESULTS -
 ORGANOCHLORINE PESTICIDES (OCPs)**
 Phase Two Environmental Site Assessment
 13030 Lundy's Lane
 Thorold, Ontario
