Phase Two Environmental Site Assessment

13030 Lundy's Lane, Thorold, Ontario

GTR-21019405-B0

July 14, 2022

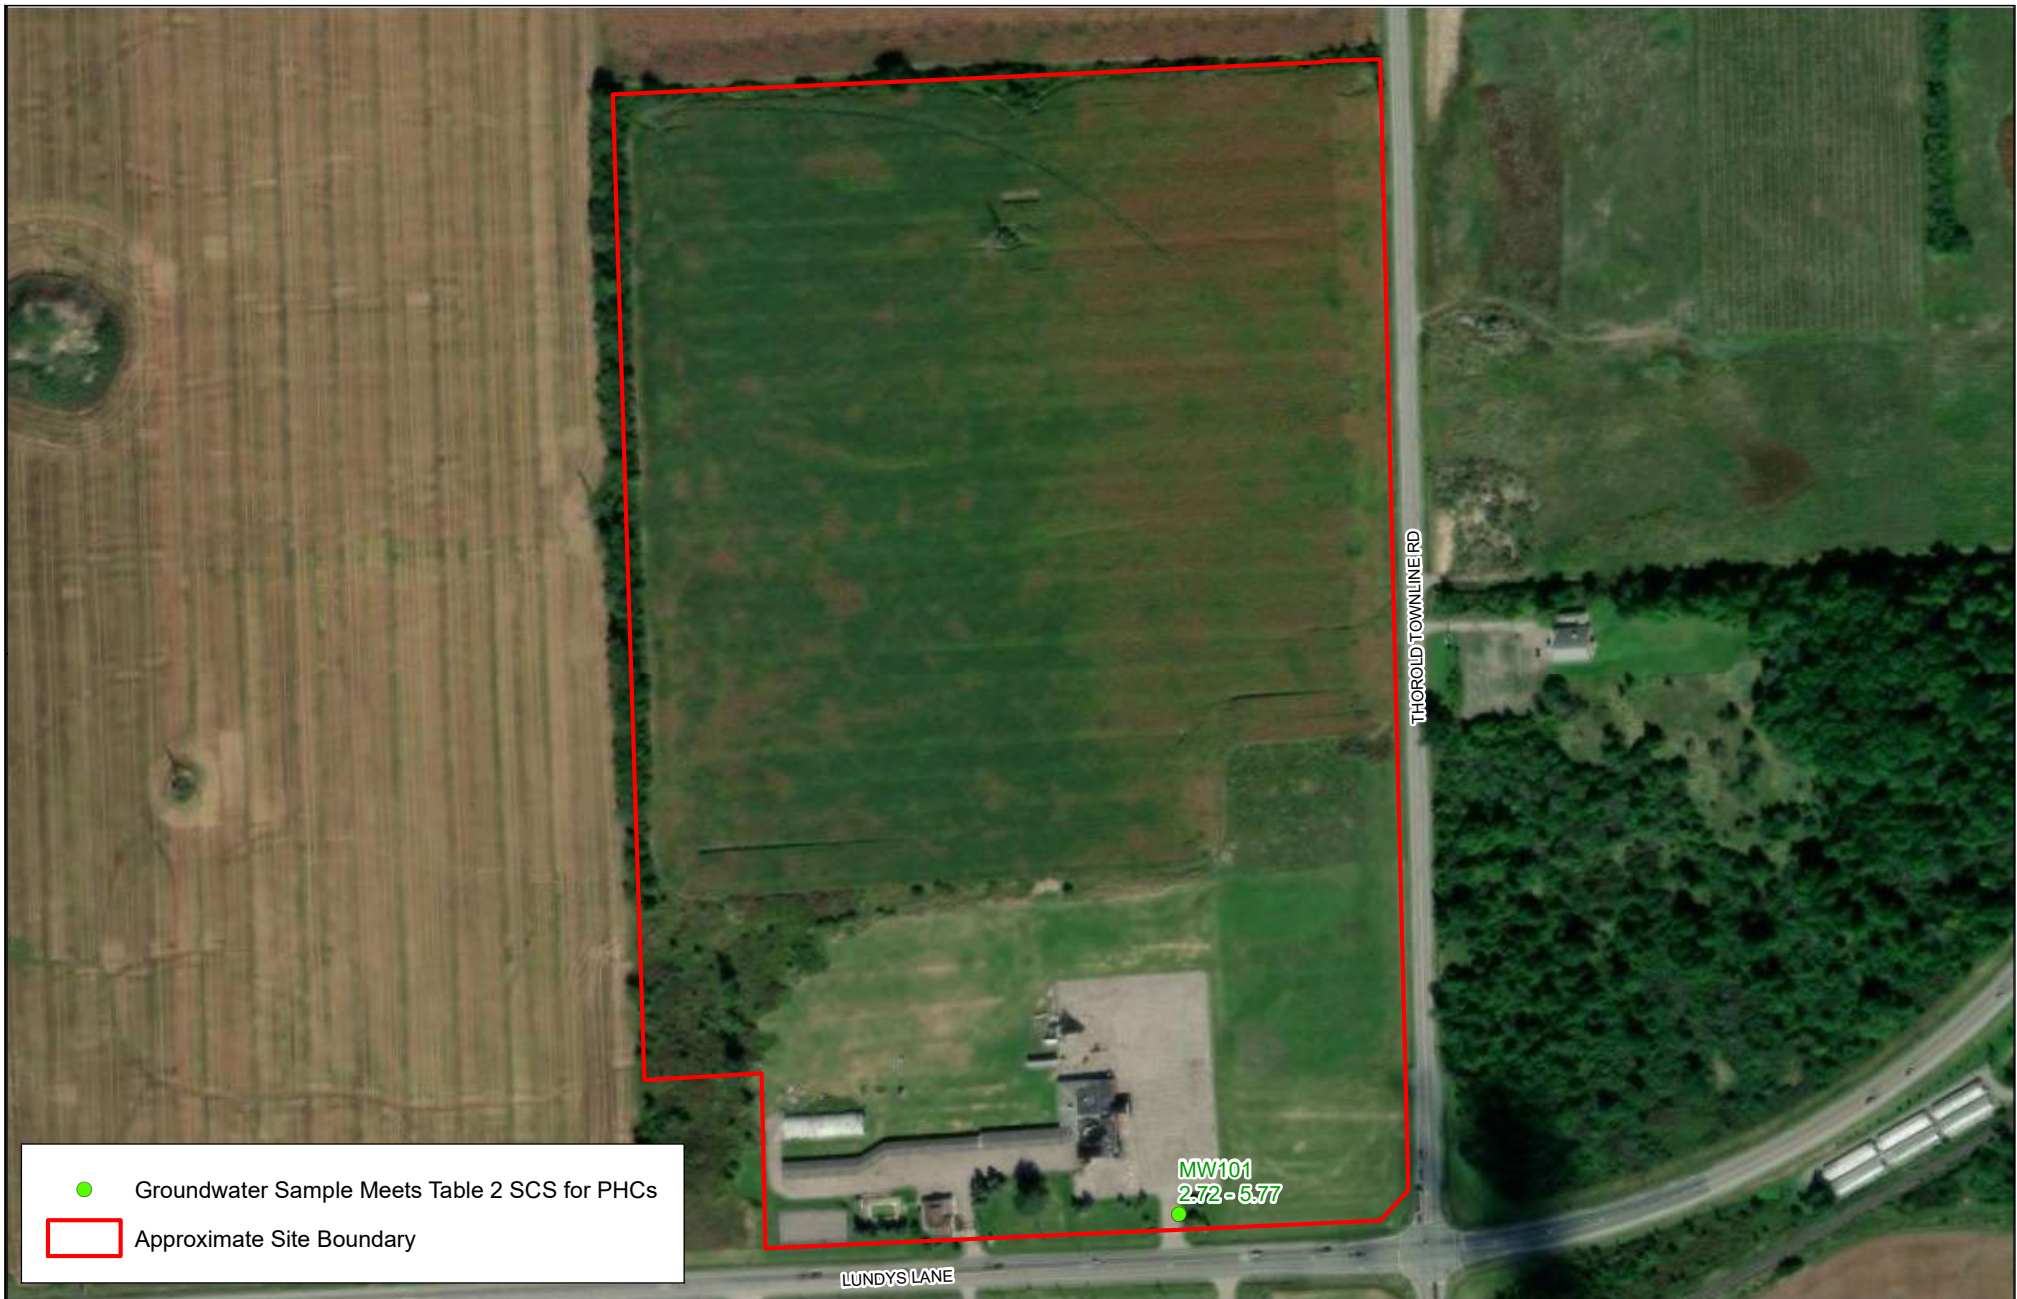
PROJECT No.: GTR-21019405-A0	OWN: AC
SCALE: AS NOTED	CHKD: LE
DATE: DECEMBER 2021	FIG. No.: 11

● Groundwater Sample Meets Table 2 SCS for PHCs
 Approximate Site Boundary

TITLE AND LOCATION:
**GROUNDWATER ANALYTICAL RESULTS -
 PETROLEUM HYDROCARBONS (PHCs)
 INCLUDING BTEX**
 Phase Two Environmental Site Assessment
 13030 Lundy's Lane
 Thorold, Ontario

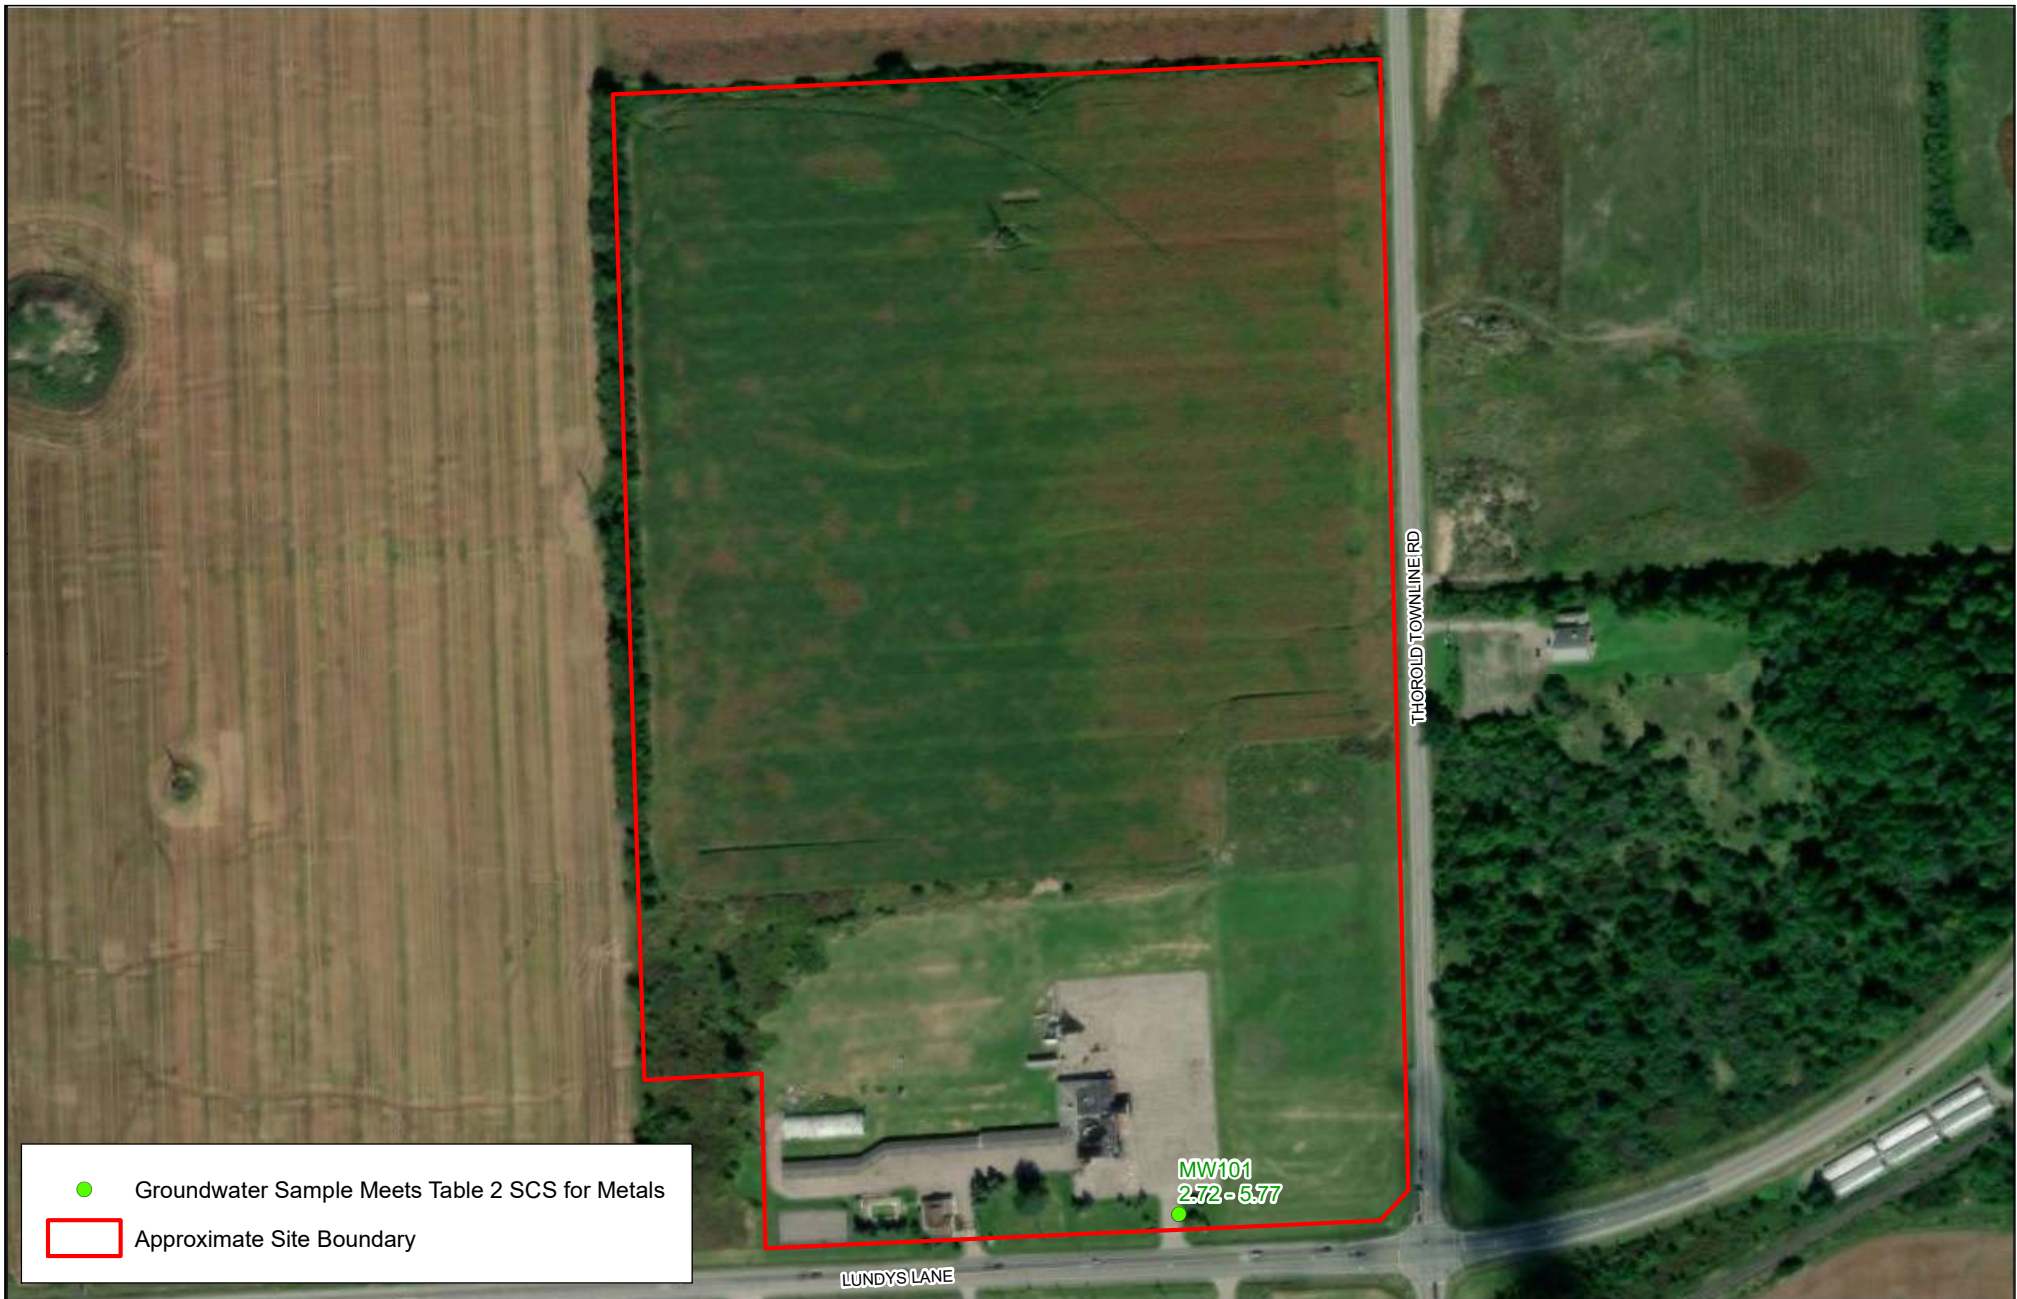
PROJECT No.:	GTR-21019405-A0	OWN:	AC
SCALE:	AS NOTED	CHKD:	LE
DATE:	DECEMBER 2021	FIG. No.:	12

- Groundwater Sample Meets Table 2 SCS for Metals
- Approximate Site Boundary
